## General Information

Date & Time: 14, Jan, 2026 12:25

<b>Make</b>	Mitsubishi	<b>Model</b>	Mirage
<b>YOM</b>	2020	<b>Odo Meter Reading</b>	41,359
<b>Registration No.</b>	CAU7440	<b>Chassis No.</b>	PAEA13RJLLA016851
<b>CC</b>	1.2	<b>Transmission</b>	A/T
<b>Fuel Type</b>	Gas	<b>Type of Body</b>	Sedan
<b>Colour</b>	Red

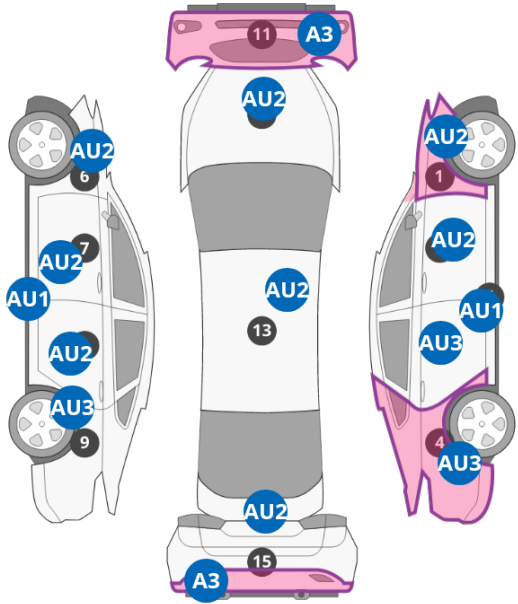
</div> <p><b>A</b> : Scratch <b>AU</b> : Scratch &amp; Dent <b>B</b> : Modified <b>C</b> : Corrosion <b>G</b> : Stone chip <b>P</b> : Faded <b>S</b> : Rust <b>SC</b> : Rust &amp; Corrosion <b>U</b> : Dent <b>X</b> : Defective <b>Y</b> : Crack, Gap</p>
<p><b>Remarks</b> (L) Front Seat - Worn - Yes / (R) Front Seat - Grime - Small / (R) Front Floor Mat - Grime - Small / (L) Front Floor Mat - Grime - Small / Mat Other - Grime - Small / (L) Front Trim - Grime - Small / (R) Front Trim - Grime - Small / Ceiling - Grime - Small / Glove Box - Worked - Minimal / Rear Seat - Grime - Small / Trunk Room - Worked - Minimal</p>	<p><b>Remarks</b> (R) Front Door - Repair Traces - Yes / (R) Front Fender - Repair Traces - Yes / Bonnet - Repair Traces - Yes / (L) Front Fender - Repair Traces - Yes / (L) Front Door - Repair Traces - Yes / (L) Rear Door - Repair Traces - Yes / (L) Rear Fender - Repair Traces - Yes / Trunk Hood, Rear Gate - Repair Traces - Yes / (R) Rear Fender - Repair Traces - Yes / (R) Rear Door - Repair Traces - Yes / Roof - Repair Traces - Yes / Overall Exterior - Full Re-Paint in same color - Yes / Bonnet, Headlight - Scratch &amp; Dent - Small / (R) Front Fender, Molding - Scratch &amp; Dent - Small / (R) Front Fender, Molding - Repair mark - Yes / (R) Front Door, Molding - Scratch &amp; Dent - Small / (R) Step, In-panel, Side Spoiler - Scratch &amp; Dent - Medium / (R) Rear Fender, Molding - Repair mark - Yes / (R) Rear Fender, Molding - Scratch &amp; Dent - Medium / Rear Bumper, Lamps, Panels - Repair mark - Difference in Color / Trunk Hood, Rear Gate - Scratch &amp; Dent - Small / Rear Bumper, Lamps, Panels - Scratch - Medium / (L) Rear Fender, Molding - Scratch &amp; Dent - Medium / (L) Step, In-panel, Side Spoiler - Scratch &amp; Dent - Minimal / (L) Rear Door, Molding - Scratch &amp; Dent - Small / (L) Front Door, Molding - Scratch &amp; Dent - Small / (L) Front Fender, Molding - Scratch &amp; Dent - Small / Roof - Scratch &amp; Dent - Small / Front Bumper, Grille, Lamps - Repair mark - Yes / Front Bumper, Grille, Lamps - Scratch - Medium / (R) Rear Door, Molding - Scratch &amp; Dent - Minimal</p>
