General Information

Make	Toyota	Model	Vios
YOM	2017	Odo Meter Reading	53,215
Registration No.	NCP7367	Chassis No.	PA1B19F33H4043218
CC	1.3	Transmission	A/T
Fuel Type	Gas	Type of Body	Sedan
Colour	Black

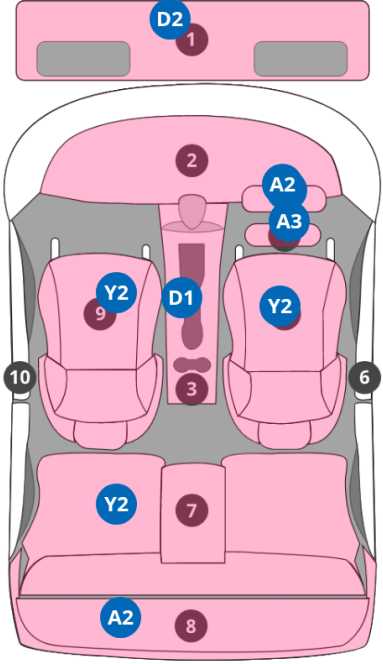
Interior Evaluation : C	Exterior Evaluation : E

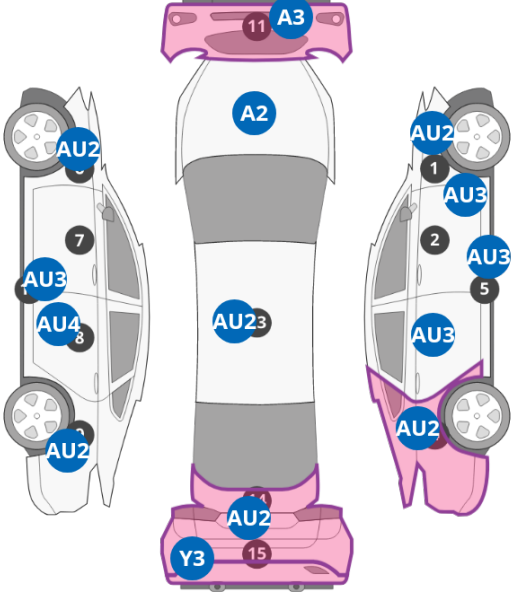
<p>A : Scratch AU : Scratch & Dent B : Modified C : Corrosion G : Stone chip P : Faded S : Rust SC : Rust & Corrosion U : Dent X : Defective Y : Crack, Gap</p>
<p>Remarks Dashboard - Worked - Minimal / Glove Box - Worn, Scratch, Cut, Crack - Small / (L) Front Floor Mat - Cut, Crack - Medium / Rear Seat - Grime - Small / (R) Front Seat - Grime - Small / (L) Front Seat - Grime - Small / Console, Switches, Vents - Worked - Minimal / Overall Interior - Worn as per age - Yes / Ceiling - Crinkle - Small / Trunk Room - Worn, Scratch, Cut, Crack - Small</p>	<p>Remarks (R) Front Door - Repair Traces - Yes / (R) Step - Repair Traces - Yes / (R) Front Fender - Repair Traces - Yes / Bonnet - Repair Traces - Yes / (L) Front Fender - Repair Traces - Yes / (L) Front Door - Repair Traces - Yes / (L) Step - Repair Traces - Yes / (L) Rear Door - Repair Traces - Yes / (L) Rear Fender - Repair Traces - Yes / Trunk Hood, Rear Gate - Repair Traces - Yes / (R) Rear Fender - Repair Traces - Yes / (R) Rear Door - Repair Traces - Yes / Roof - Repair Traces - Yes / Bonnet, Headlight - Scratch - Small / Overall Exterior - Full Re-Paint in same color - Yes / Front Bumper, Grille, Lamps - Scratch - Medium / Front Bumper, Grille, Lamps - Repair mark - Yes / (R) Front Fender, Molding - Scratch & Dent - Small / (R) Front Door, Molding - Scratch & Dent - Medium / (R) Step, In-panel, Side Spoiler - Scratch & Dent - Medium / (R) Rear Door, Molding - Scratch & Dent - Medium / (R) Rear Fender, Molding - Repair mark - Yes / (R) Rear Fender, Molding - Scratch & Dent - Small / Rear Bumper, Lamps, Panels - Crack, Gap - Medium / (L) Rear Fender, Molding - Scratch & Dent - Small / (L) Rear Door, Molding - Scratch & Dent - Large / (L) Front Door, Molding - Scratch & Dent - Medium / (L) Front Fender, Molding - Scratch & Dent - Small / Roof - Scratch & Dent - Small / Trunk Hood, Rear Gate - Scratch & Dent - Small / Trunk Hood, Rear Gate - Repair mark - Yes / Rear Bumper, Lamps, Panels - Repair mark - Yes</p>
