## General Information

<b>Make</b>	Geely	<b>Model</b>	Coolray
<b>YOM</b>	2022	<b>Odo Meter Reading</b>	23,157
<b>Registration No.</b>	DAS2644	<b>Chassis No.</b>	LB37622Z3NX416617
<b>CC</b>	1.5	<b>Transmission</b>	A/T
<b>Fuel Type</b>	Gas	<b>Type of Body</b>	SUV
<b>Colour</b>	Silver

## Body / Panel Condition

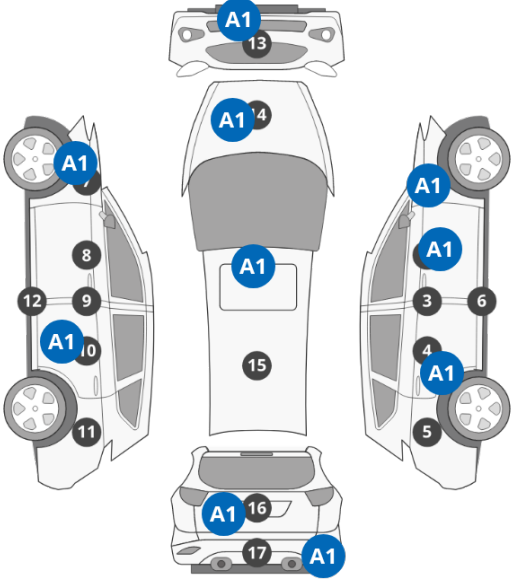
<p><b>A</b> : Scratch <b>AU</b> : Scratch &amp; Dent <b>B</b> : Modified <b>C</b> : Corrosion <b>G</b> : Stone chip <b>P</b> : Faded <b>S</b> : Rust <b>SC</b> : Rust &amp; Corrosion <b>U</b> : Dent <b>X</b> : Defective <b>Y</b> : Crack, Gap</p>
<p><b>Remarks</b> Defects not found</p>	<p><b>Remarks</b> (R) Front Fender, Molding - Scratch - Minimal / (R) Front Door, Molding - Scratch - Minimal / (R) Rear Door, Molding - Scratch - Minimal / Rear Bumper, Lamps, Panels - Scratch - Minimal / Trunk Hood, Rear Gate - Scratch - Minimal / (L) Rear Door, Molding - Scratch - Minimal / (L) Front Fender, Molding - Scratch - Minimal / Bonnet, Headlight - Scratch - Minimal / Roof - Scratch - Minimal / Front Bumper, Grille, Lamps - Scratch - Minimal</p>
