## General Information

<b>Make</b>	Mitsubishi	<b>Model</b>	Mirage
<b>YOM</b>	2023	<b>Odo Meter Reading</b>	31,200
<b>Registration No.</b>	NEE4756	<b>Chassis No.</b>	PAEA13TJJPA004244
<b>CC</b>	1.2	<b>Transmission</b>	A/T
<b>Fuel Type</b>	Gas	<b>Type of Body</b>	Sedan
<b>Colour</b>	Silver

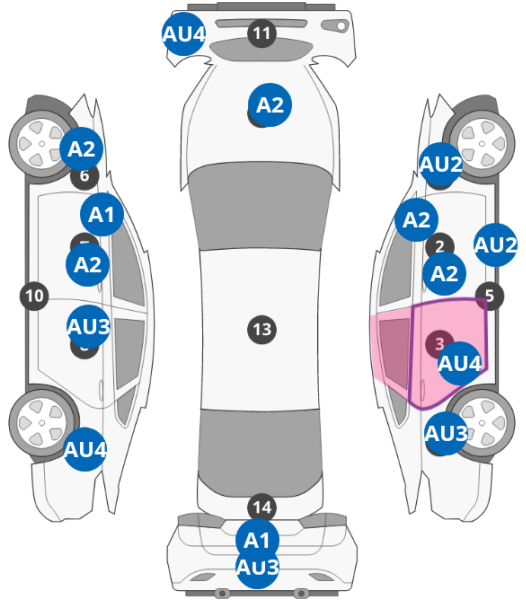
<p><b>A</b> : Scratch <b>AU</b> : Scratch &amp; Dent <b>B</b> : Modified <b>C</b> : Corrosion <b>G</b> : Stone chip <b>P</b> : Faded <b>S</b> : Rust <b>SC</b> : Rust &amp; Corrosion <b>U</b> : Dent <b>X</b> : Defective <b>Y</b> : Crack, Gap</p>
<b>Remarks</b> (R) Front Seat - Grime - Small / Rear Seat - Grime - Medium	<b>Remarks</b> (R) Front Door - Repair Traces - Yes / (R) Front Fender - Repair Traces - Yes / Bonnet - Repair Traces - Yes / (L) Front Fender - Repair Traces - Yes / (L) Front Door - Repair Traces - Yes / (L) Rear Door - Repair Traces - Yes / (L) Rear Fender - Repair Traces - Yes / Trunk Hood, Rear Gate - Repair Traces - Yes / (R) Rear Fender - Repair Traces - Yes / (R) Rear Door - Repair Traces - Yes / Roof - Repair Traces - Yes / Overall Exterior - Full Re-Paint in same color - Yes / (R) Front Fender, Molding - Scratch & Dent - Small / (R) Mirror - Scratch - Small / (R) Front Door, Molding - Scratch - Small / (R) Step, In-panel, Side Spoiler - Scratch & Dent - Small / (R) Rear Door, Molding - Scratch & Dent - Large / (R) Rear Fender, Molding - Scratch & Dent - Medium / (R) Rear Door, Molding - Repair mark - Difference in Color / Rear Bumper, Lamps, Panels - Scratch & Dent - Medium / Trunk Hood, Rear Gate - Scratch - Minimal / (L) Rear Fender, Molding - Scratch & Dent - Large / (L) Rear Door, Molding - Scratch & Dent - Medium / (L) Front Door, Molding - Scratch - Small / (L) Mirror - Scratch - Minimal / (L) Front Fender, Molding - Scratch - Small / Front Bumper, Grille, Lamps - Scratch & Dent - Large / Bonnet, Headlight - Scratch - Small
