## General Information

| <b>Make</b> | Toyota | <b>Model</b> | Hiace |
| <b>Registration No.</b> | GAW4107 | <b>Chassis No.</b> | JTFNAFAP3M8023580 |

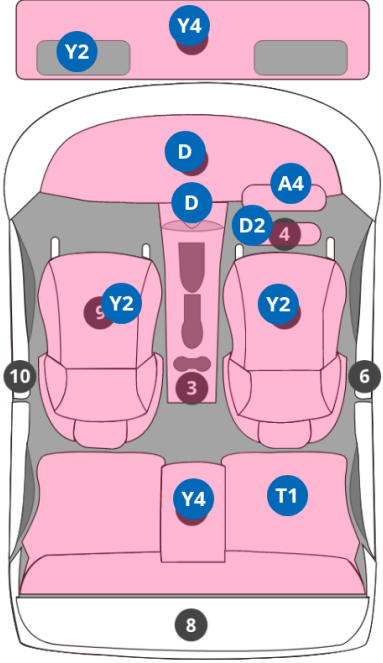
| <b>Interior Evaluation :</b> <span style="float: right; color: red; font-weight: bold;">D</span> | <b>Exterior Evaluation :</b> <span style="float: right; color: red; font-weight: bold;">E</span> |
| <p><b>Remarks</b><br/>(R) Front Seat - Grime - Small / Console, Switches, Vents - Traces of Adhesive Tape - Yes / Dashboard - Traces of Adhesive Tape - Yes / (L) Front Floor Mat - Worked - Small / Rear Seat - Grime - Large / Rear Seat - Cigarette Burns - Burnt Minimal / Ceiling - Grime - Large / Steering Wheel - Worn, Peel, Crack - Large / (L) Front Seat - Grime - Small / Sunvisor, Sunglass Holder - Grime - Small / Overall Interior - Worn as per age - Yes</p> | <p><b>Remarks</b><br/>Overall Exterior - Faded(Color, Gloss) - Yes / (L) Front Fender, Molding - Scratch &amp; Dent - Large / (L) Mirror - Scratch - Medium / (L) Front Door, Molding - Scratch &amp; Dent - Large / (L) Rear Fender, Molding - Scratch &amp; Dent - Large / Trunk Hood, Rear Gate - Dent - Medium / Rear Bumper, Lamps, Panels - Scratch &amp; Dent - Large / (R) Rear Fender, Molding - Scratch - Medium / (R) Rear Door, Molding - Scratch &amp; Dent - Large / (R) Center Panel - Scratch &amp; Dent - Large / (R) Front Door, Molding - Scratch &amp; Dent - Medium / (R) Mirror - Scratch - Medium / (R) Front Fender, Molding - Scratch &amp; Dent - Medium / Front Bumper, Grille, Lamps - Modified - Large / Front Bumper, Grille, Lamps - Scratch &amp; Dent - Large / Bonnet, Headlight - Scratch - Small / Roof - Scratch - Small / Front Windshield - Damaged - Large</p> |
