## General Information

| Make | Toyota | Model | Hiace |
| Registration No. | GAW3925 | Chassis No. | JTFNAFAP4M8023524 |

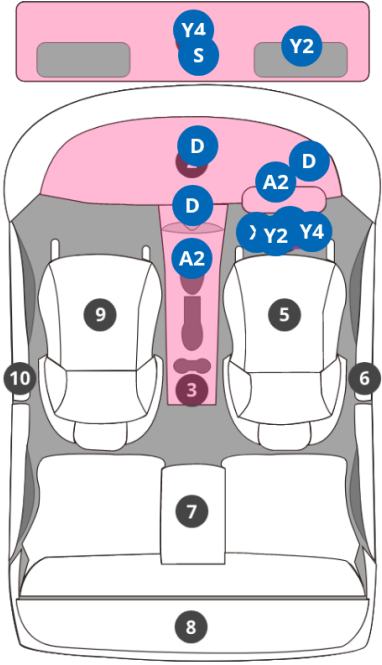
| Interior Evaluation : <b>D</b> | Exterior Evaluation : <b>E</b> |
|---|---|
| <b>Remarks</b><br>(L) Front Floor Mat - Missing - Yes / Carpet - Worked - Large / Dashboard - Traces of Adhesive Tape - Yes / Console, Switches, Vents - Traces of Adhesive Tape - Yes / Mat Other - Grime - Large / Ceiling - Grime - Large / (R) Front Floor Mat - Grime - Small / Overall Interior - Worn as per age - Yes / Overall Interior - Smell - Yes / Steering Wheel - Worn, Peel, Crack - Small / Glove Box - Traces of Adhesive Tape - Yes / Sunvisor, Sunglass Holder - Grime - Small / Knobs - Worn, Peel, Crack - Small | <b>Remarks</b><br>(R) Step - Repair Traces - Yes / (L) Step - Repair Traces - Yes / (R) Rear Fender - Repair Traces - Yes / (R) Rear Door - Repair Traces - Yes / Overall Exterior - Faded(Color, Gloss) - Yes / (L) Rear Fender, Molding - Scratch - Large / (L) Center Panel - Scratch - Small / (L) Mirror - Scratch - Medium / (L) Front Fender, Molding - Scratch - Small / (L) Front Door, Molding - Scratch - Medium / Trunk Hood, Rear Gate - Scratch & Dent - Medium / Rear Bumper, Lamps, Panels - Scratch - Large / (R) Rear Fender, Molding - Repair mark - Yes / (R) Rear Fender, Molding - Crack, Gap - Large / (R) Rear Door, Molding - Repair mark - Yes / Rear Bumper, Lamps, Panels - Repair mark - Yes / (R) Rear Door, Molding - Scratch & Dent - Large / (R) Center Panel - Scratch - Medium / (R) Mirror - Scratch - Medium / (R) Front Door, Molding - Scratch - Medium / (R) Front Fender, Molding - Scratch & Dent - Medium / Bonnet, Headlight - Repair mark - Yes / Front Bumper, Grille, Lamps - Scratch & Dent - Large / Roof - Repair mark - Yes |
