General Information

Make	Hyundai	Model	Accent
YOM	2019	Odo Meter Reading	54,856
Registration No.	NEH1999-SELLER'S YARD	Chassis No.	PAHC741BBKH00973
CC	1.4	Transmission	A/T
Fuel Type	Gas	Type of Body	Sedan
Colour	Silver

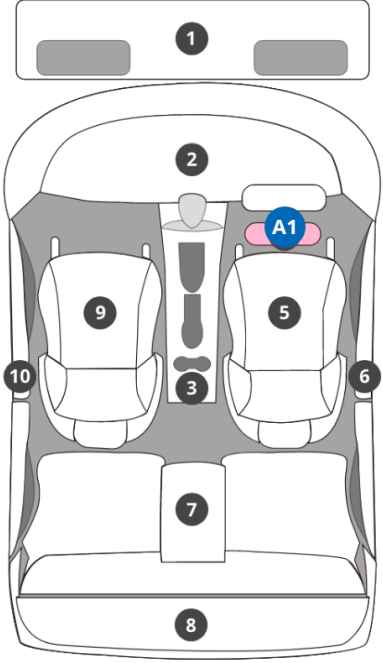
Interior Evaluation : A	Exterior Evaluation : E

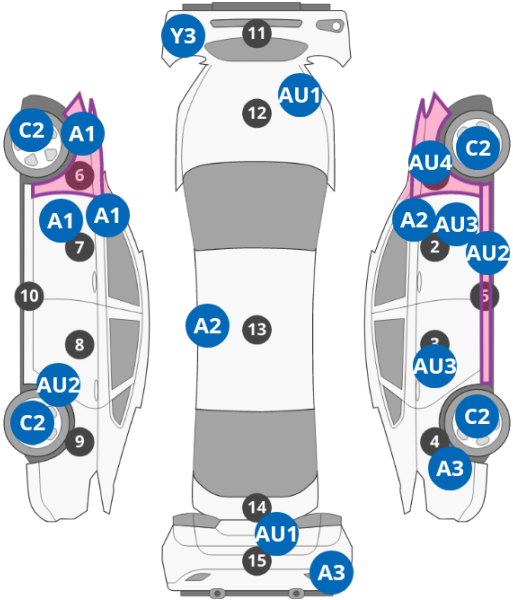
<p>A : Scratch AU : Scratch & Dent B : Modified C : Corrosion G : Stone chip P : Faded S : Rust SC : Rust & Corrosion U : Dent X : Defective Y : Crack, Gap</p>
<p>Remarks (L) Front Floor Mat - Cut, Crack - Minimal</p>	<p>Remarks (R) Front Fender, Molding - Repair mark - Yes / (R) Front Fender, Molding - Scratch & Dent - Large / (R) Mirror - Scratch - Small / (R) Front Wheel, Cover - Scratch, Corrosion - Small / (R) Step, In-panel, Side Spoiler - Repair mark - Yes / (R) Step, In-panel, Side Spoiler - Scratch & Dent - Small / (R) Front Door, Molding - Scratch & Dent - Medium / (R) Rear Door, Molding - Scratch & Dent - Medium / (R) Rear Wheel, Cover - Scratch, Corrosion - Small / (R) Rear Fender, Molding - Scratch - Medium / Rear Bumper, Lamps, Panels - Scratch - Medium / Trunk Hood, Rear Gate - Scratch & Dent - Minimal / (L) Rear Wheel, Cover - Scratch, Corrosion - Small / (L) Front Wheel, Cover - Scratch, Corrosion - Small / (L) Rear Fender, Molding - Scratch & Dent - Small / (L) Front Door, Molding - Scratch - Minimal / (L) Front Fender, Molding - Repair mark - Yes / (L) Front Fender, Molding - Scratch - Minimal / Front Bumper, Grille, Lamps - Crack, Gap - Medium / Roof - Scratch - Small / Bonnet, Headlight - Scratch & Dent - Minimal / (L) Mirror - Scratch - Minimal</p>
