## General Information

<b>Make</b>	Toyota	<b>Model</b>	Vios
<b>YOM</b>	2022	<b>Odo Meter Reading</b>	38,029
<b>Registration No.</b>	GAS5644	<b>Chassis No.</b>	PA1B18F38N4189779
<b>CC</b>	1.3	<b>Transmission</b>	CVT
<b>Fuel Type</b>	Gas	<b>Type of Body</b>	Sedan
<b>Colour</b>	Red Mica Metallic

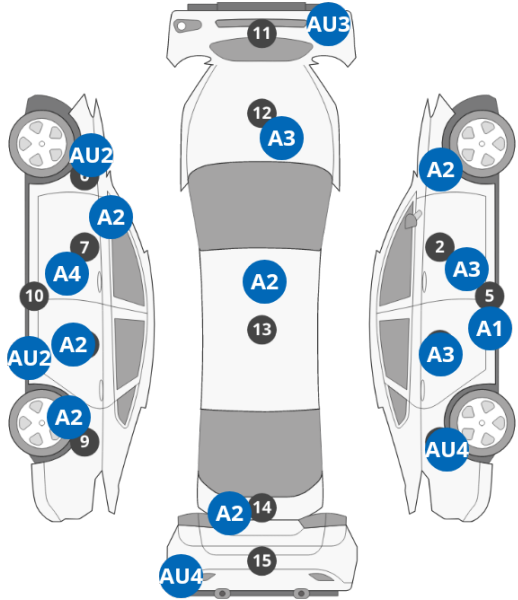
<p><b>A</b> : Scratch <b>AU</b> : Scratch &amp; Dent <b>B</b> : Modified <b>C</b> : Corrosion <b>G</b> : Stone chip <b>P</b> : Faded <b>S</b> : Rust <b>SC</b> : Rust &amp; Corrosion <b>U</b> : Dent <b>X</b> : Defective <b>Y</b> : Crack, Gap</p>
<p><b>Remarks</b> (L) Front Trim - Grime - Small / (L) Front Floor Mat - Worked - Small / Sunvisor, Sunglass Holder - Grime - Small / Mat Other - Grime - Medium / (R) Front Trim - Grime - Small / Ceiling - Grime - Medium / (R) Front Floor Mat - Grime - Small</p>	<p><b>Remarks</b> (L) Front Fender, Molding - Scratch &amp; Dent - Small / (L) Mirror - Scratch - Small / (L) Rear Door, Molding - Scratch - Small / (L) Front Door, Molding - Scratch - Large / (L) Step, In-panel, Side Spoiler - Scratch &amp; Dent - Small / (L) Rear Fender, Molding - Scratch - Small / Rear Bumper, Lamps, Panels - Scratch &amp; Dent - Large / Trunk Hood, Rear Gate - Scratch - Small / (R) Rear Fender, Molding - Scratch &amp; Dent - Large / (R) Rear Door, Molding - Scratch - Medium / (R) Front Door, Molding - Scratch - Medium / (R) Step, In-panel, Side Spoiler - Scratch - Minimal / (R) Front Fender, Molding - Scratch - Small / Bonnet, Headlight - Scratch - Medium / Roof - Scratch - Small / Front Bumper, Grille, Lamps - Scratch &amp; Dent - Medium</p>
