## General Information

<b>Make</b>	Mitsubishi	<b>Model</b>	Xpander
<b>YOM</b>	2019	<b>Odo Meter Reading</b>	61,433
<b>Registration No.</b>	DAJ5441	<b>Chassis No.</b>	MK2XRVC1WKN015059
<b>CC</b>	1.5	<b>Transmission</b>	A/T
<b>Fuel Type</b>	Gas	<b>Type of Body</b>	Wagon
<b>Colour</b>	Silver

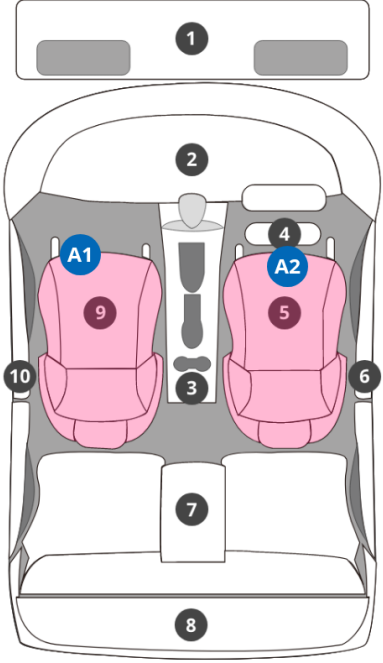
<b>Interior Evaluation :</b> <span style="float: right; color: red; font-weight: bold;">A</span>	<b>Exterior Evaluation :</b> <span style="float: right; color: red; font-weight: bold;">E</span>

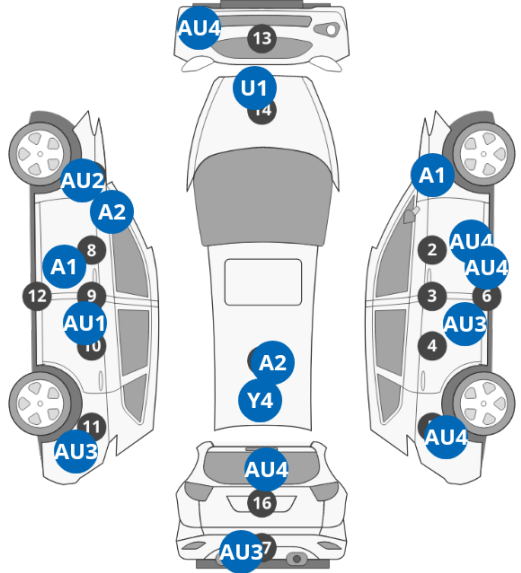
<p><b>A</b> : Scratch <b>AU</b> : Scratch &amp; Dent <b>B</b> : Modified <b>C</b> : Corrosion <b>G</b> : Stone chip <b>P</b> : Faded <b>S</b> : Rust <b>SC</b> : Rust &amp; Corrosion <b>U</b> : Dent <b>X</b> : Defective <b>Y</b> : Crack, Gap</p>
<p><b>Remarks</b> (R) Front Seat - Cut, Crack - Small / (L) Front Seat - Cut, Crack - Minimal</p>	<p><b>Remarks</b> (R) Front Fender, Molding - Scratch - Minimal / (R) Front Door, Molding - Scratch &amp; Dent - Large / (R) Step, In-panel, Side Spoiler - Scratch &amp; Dent - Large / (R) Rear Door, Molding - Scratch &amp; Dent - Medium / (R) Rear Fender, Molding - Scratch &amp; Dent - Large / Trunk Hood, Rear Gate - Scratch &amp; Dent - Large / Rear Bumper, Lamps, Panels - Scratch &amp; Dent - Medium / Rear Windshield - Damaged - Large / (L) Rear Fender, Molding - Scratch &amp; Dent - Medium / (L) Rear Door, Molding - Scratch &amp; Dent - Minimal / (L) Mirror - Scratch - Small / (L) Front Door, Molding - Scratch - Minimal / (L) Front Fender, Molding - Scratch &amp; Dent - Small / Front Bumper, Grille, Lamps - Scratch &amp; Dent - Large / Bonnet, Headlight - Dent - Minimal / Roof - Scratch - Small</p>
