## General Information

<b>Make</b>	Mitsubishi	<b>Model</b>	Mirage
<b>YOM</b>	2017	<b>Odo Meter Reading</b>	101,246
<b>Registration No.</b>	NBX6365	<b>Chassis No.</b>	PAEA13TJHHA000416
<b>CC</b>	1.2	<b>Transmission</b>	A/T
<b>Fuel Type</b>	Gas	<b>Type of Body</b>	Sedan
<b>Colour</b>	Gray

## Body / Panel Condition

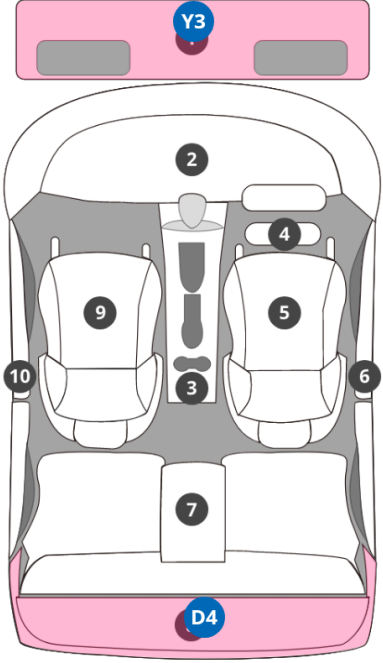
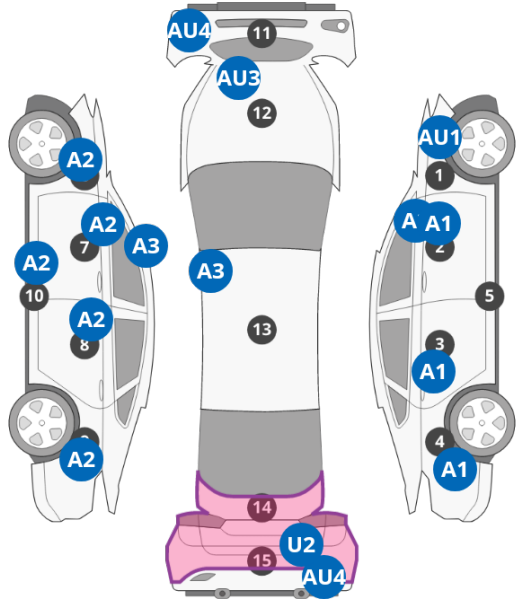
<b>Interior Evaluation :</b>	C	<b>Exterior Evaluation :</b>	E

<p><b>a</b> : Cut, Fray <b>d</b> : Loose, Deformed <b>k</b> : Animal Hair <b>s</b> : Smell <b>t</b> : Cigarette Burns <b>x</b> : Defective <b>y</b> : Stain</p>		<p><b>A</b> : Scratch <b>AU</b> : Scratch &amp; Dent <b>B</b> : Modified <b>C</b> : Corrosion <b>G</b> : Stone chip <b>P</b> : Faded <b>S</b> : Rust <b>SC</b> : Rust &amp; Corrosion <b>U</b> : Dent <b>X</b> : Defective <b>Y</b> : Crack, Gap</p>	
<p><b>Remarks</b> Sunvisor, Sunglass Holder - Grime - Medium / Trunk Room - Loose, Deformed - Large</p>		<p><b>Remarks</b> Trunk Hood, Rear Gate - Repair Traces - Yes / (R) Front Fender, Molding - Scratch &amp; Dent - Minimal / (R) Mirror - Scratch - Small / (R) Front Door, Molding - Scratch - Minimal / (R) Rear Door, Molding - Scratch - Minimal / (R) Rear Fender, Molding - Scratch - Minimal / Rear Bumper, Lamps, Panels - Scratch &amp; Dent - Large / Trunk Hood, Rear Gate - Repair mark - Yes / Trunk Hood, Rear Gate - Dent - Small / (L) Rear Fender, Molding - Scratch - Small / (L) Rear Door, Molding - Scratch - Small / (L) Step, In-panel, Side Spoiler - Scratch - Small / (L) Mirror - Scratch - Small / (L) Front Fender, Molding - Scratch - Small / Front Bumper, Grille, Lamps - Scratch &amp; Dent - Large / Bonnet, Headlight - Scratch &amp; Dent - Medium / (L) Front Door, Molding - Scratch - Medium / Roof - Scratch - Medium</p>
