General Information

Date & Time: 14, Jan, 2026 16:00

Make	Hyundai	Model	H100
YOM	2020	Odo Meter Reading	108,189
Registration No.	NDM9326	Chassis No.	KMFZBX7KAKU672562
CC	2.5	Transmission	M/T
Fuel Type	Diesel	Type of Body	Shuttle
Colour	White

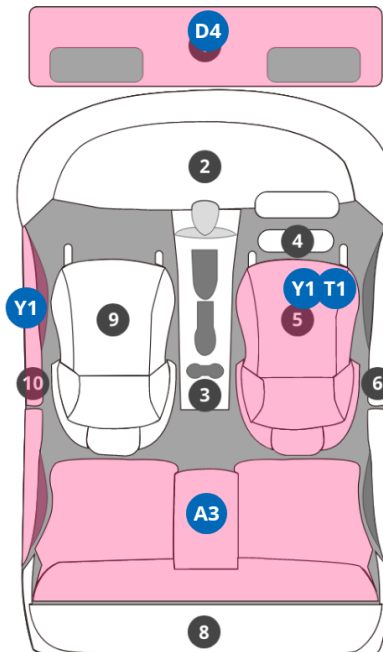
Interior Evaluation : C	Exterior Evaluation : C

<p>A : Scratch AU : Scratch & Dent B : Modified C : Corrosion G : Stone chip P : Faded S : Rust SC : Rust & Corrosion U : Dent X : Defective Y : Crack, Gap</p>
<p>Remarks (R) Front Seat - Cigarette Burns - Burnt Minimal / (L) Front Trim - Grime - Minimal / (R) Front Seat - Grime - Minimal / Rear Seat - Cut, Crack - Medium / Ceiling - Loose, Deformed - Large</p>	<p>Remarks (R) Front Door - Repair Traces - Yes / (R) Front Fender - Repair Traces - Yes / Bonnet - Repair Traces - Yes / (L) Front Fender - Repair Traces - Yes / (L) Front Door - Repair Traces - Yes / (L) Rear Corner Panel - Repair Traces - Yes / Roof - Repair Traces - Yes / Overall Exterior - Full Re-Paint in same color - Yes / (R) Front Fender, Molding - Scratch - Minimal / (R) Mirror - Scratch - Small / (R) Front Door, Molding - Scratch - Small / (R) Center Panel - Scratch - Minimal / (R) Side Gate - Scratch & Dent - Medium / Rear Bumper, Lamps, Panels - Crack, Gap - Medium / Rear Gate - Scratch - Small / (L) Side Gate - Scratch & Dent - Small / (L) Center Panel - Scratch - Small / (L) Mirror - Scratch - Small / (L) Front Door, Molding - Scratch - Minimal / (L) Front Fender, Molding - Scratch - Minimal / Front Bumper, Grille, Lamps - Crack, Gap - Medium / Bonnet, Headlight - Scratch - Minimal / Roof - Dent - Small</p>
