General Information

| Make | Toyota | Model | Vios |
| YOM | 2025 | Odo Meter Reading | 13,724 |
| Registration No. | IAF9134 | Chassis No. | PA1B18F39R4268836 |

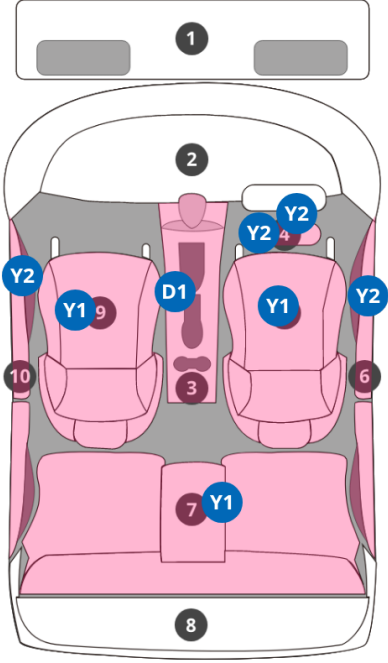
| Interior Evaluation : B | Exterior Evaluation : D |
| <p>Remarks (L) Front Floor Mat - Grime - Small / (R) Front Floor Mat - Grime - Small / (L) Front Trim - Grime - Small / (R) Front Trim - Grime - Small / (L) Front Seat - Grime - Minimal / (R) Front Seat - Grime - Minimal / Rear Seat - Grime - Minimal / Console, Switchs, Vents - Worked - Minimal</p> | <p>Remarks (R) Front Fender, Molding - Repair mark - Yes / (R) Front Fender, Molding - Scratch - Small / Bonnet, Headlight - Scratch & Dent - Medium / (L) Front Fender, Molding - Scratch & Dent - Small / Front Bumper, Grille, Lamps - Scratch & Dent - Small / (L) Front Door, Molding - Scratch - Medium / (L) Rear Door, Molding - Scratch & Dent - Minimal / (L) Rear Fender, Molding - Scratch & Dent - Small / Trunk Hood, Rear Gate - Scratch - Small / (R) Rear Fender, Molding - Scratch - Small / (R) Rear Door, Molding - Scratch - Medium / (R) Front Door, Molding - Scratch - Small / (R) Step, In-panel, Side Spoiler - Scratch - Minimal / (L) Step, In-panel, Side Spoiler - Scratch - Minimal / Roof - Scratch & Dent - Minimal</p> |

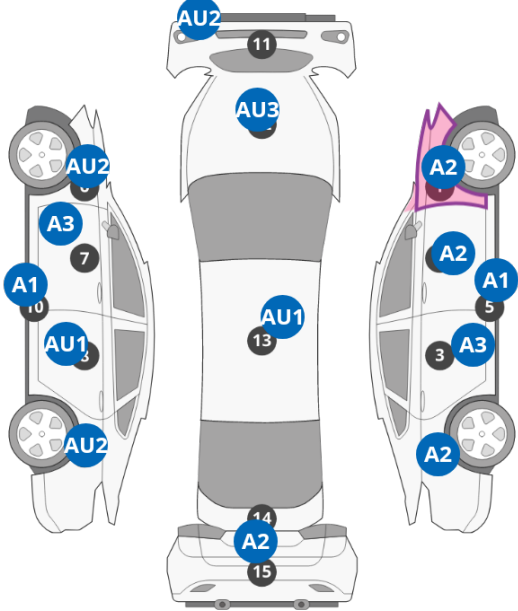
| <p>with LTO plate, with warranty and manual booklet, with spare tire, with spare key, with reverse camera, no tools & jack, scratches on taillight.</p> |
