General Information

| Make | Toyota | Model | Vios |
| Registration No. | HAH4490 | Chassis No. | PA1B18F30R4264271 |

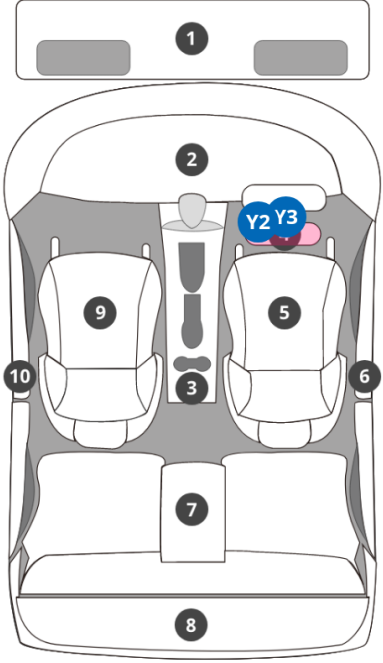
| Interior Evaluation : B | Exterior Evaluation : B |
| <p>Remarks Mat Other - Grime - Medium / (R) Front Floor Mat - Grime - Small</p> | <p>Remarks (R) Front Fender, Molding - Scratch - Small / (R) Front Door, Molding - Scratch - Minimal / (R) Step, In-panel, Side Spoiler - Scratch - Minimal / (R) Rear Door, Molding - Scratch - Minimal / Trunk Hood, Rear Gate - Scratch - Small / Rear Bumper, Lamps, Panels - Scratch - Minimal / (L) Rear Fender, Molding - Scratch & Dent - Minimal / (L) Rear Door, Molding - Scratch - Small / (L) Mirror - Scratch - Minimal / (L) Front Door, Molding - Scratch - Minimal / (L) Front Fender, Molding - Scratch - Minimal / Bonnet, Headlight - Scratch - Minimal / Front Bumper, Grille, Lamps - Scratch - Small</p> |

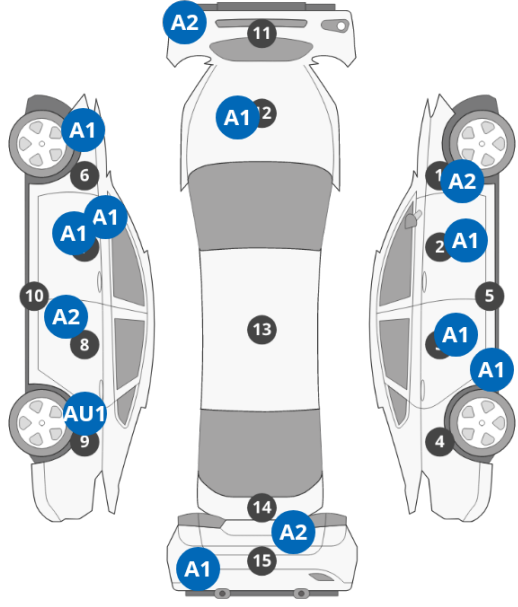
| <p>No Lto plate, with spare tire, 1key, no warranty booklet, no jack and tools, scratches on headlights and taillights</p> |
