## General Information

<b>Make</b>	Toyota	<b>Model</b>	Wigo
<b>YOM</b>	2023	<b>Odo Meter Reading</b>	26,767
<b>Registration No.</b>	CAZ7701	<b>Chassis No.</b>	MHKAA1BC2PJ003247
<b>CC</b>	1.0	<b>Transmission</b>	CVT
<b>Fuel Type</b>	Gas	<b>Type of Body</b>	Hatchback
<b>Colour</b>	Silver

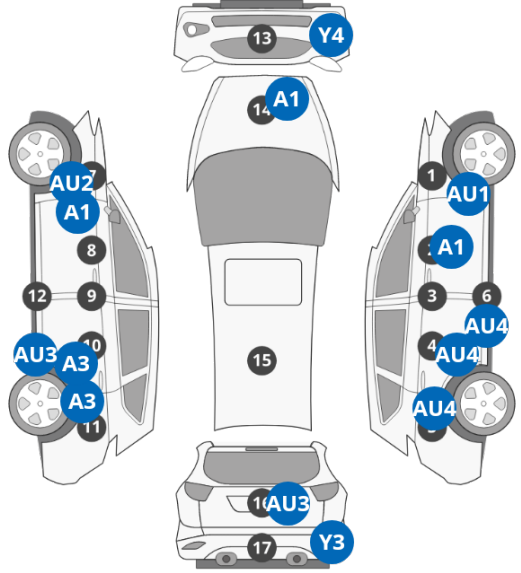
<p><b>A</b> : Scratch <b>AU</b> : Scratch &amp; Dent <b>B</b> : Modified <b>C</b> : Corrosion <b>G</b> : Stone chip <b>P</b> : Faded <b>S</b> : Rust <b>SC</b> : Rust &amp; Corrosion <b>U</b> : Dent <b>X</b> : Defective <b>Y</b> : Crack, Gap</p>
<b>Remarks</b> Defects not found	<b>Remarks</b> (R) Front Fender, Molding - Scratch & Dent - Minimal / (R) Front Door, Molding - Scratch - Minimal / (R) Step, In-panel, Side Spoiler - Scratch & Dent - Large / (R) Rear Door, Molding - Scratch & Dent - Large / (R) Rear Fender, Molding - Scratch & Dent - Large / Trunk Hood, Rear Gate - Scratch & Dent - Medium / Rear Bumper, Lamps, Panels - Crack, Gap - Medium / (L) Rear Fender, Molding - Scratch - Medium / (L) Rear Door, Molding - Scratch - Medium / (L) Step, In-panel, Side Spoiler - Scratch & Dent - Medium / (L) Front Door, Molding - Scratch - Minimal / (L) Front Fender, Molding - Scratch & Dent - Small / Front Bumper, Grille, Lamps - Crack, Gap - Large / Bonnet, Headlight - Scratch - Minimal
