## General Information

<b>Make</b>	Toyota	<b>Model</b>	Vios
<b>YOM</b>	2023	<b>Odo Meter Reading</b>	80,182
<b>Registration No.</b>	NIO3318	<b>Chassis No.</b>	PA1B18F38P4214750
<b>CC</b>	1.3	<b>Transmission</b>	CVT
<b>Fuel Type</b>	Gas	<b>Type of Body</b>	Sedan
<b>Colour</b>	Green

## Body / Panel Condition

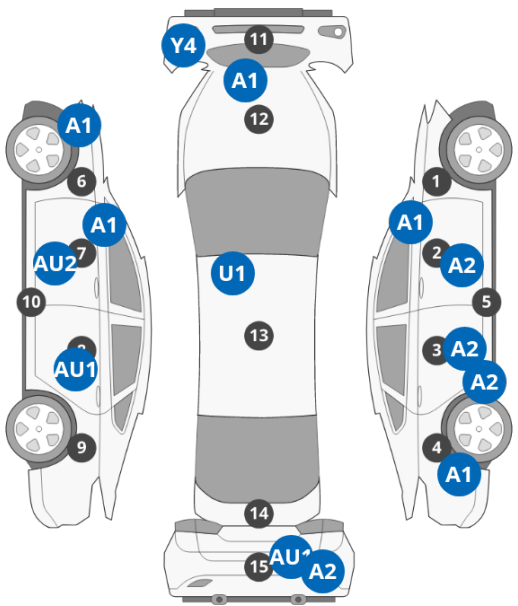
<p><b>A</b> : Scratch <b>AU</b> : Scratch &amp; Dent <b>B</b> : Modified <b>C</b> : Corrosion <b>G</b> : Stone chip <b>P</b> : Faded <b>S</b> : Rust <b>SC</b> : Rust &amp; Corrosion <b>U</b> : Dent <b>X</b> : Defective <b>Y</b> : Crack, Gap</p>
<b>Remarks</b> (L) Front Trim - Grime - Small	<b>Remarks</b> (R) Step - Repair Traces - Yes / Bonnet - Repair Traces - Yes / (L) Front Fender - Repair Traces - Yes / (L) Front Door - Repair Traces - Yes / (L) Step - Repair Traces - Yes / Overall Exterior - Full Re-Paint in same color - Yes / (R) Mirror - Scratch - Minimal / (R) Front Door, Molding - Scratch - Small / (R) Rear Door, Molding - Scratch - Small / (R) Step, In-panel, Side Spoiler - Scratch - Small / (R) Rear Fender, Molding - Scratch - Minimal / Trunk Hood, Rear Gate - Scratch & Dent - Minimal / Rear Bumper, Lamps, Panels - Scratch - Small / (L) Rear Door, Molding - Scratch & Dent - Minimal / (L) Mirror - Scratch - Minimal / (L) Front Door, Molding - Scratch & Dent - Small / (L) Front Fender, Molding - Scratch - Minimal / Front Bumper, Grille, Lamps - Crack, Gap - Large / Roof - Dent - Minimal / Bonnet, Headlight - Scratch - Minimal
