General Information

Date & Time: 10, Jan, 2026 14:18

Make	Toyota	Model	Vios
YOM	2021	Odo Meter Reading	56,555
Registration No.	NGL9233	Chassis No.	PA1B18F3XM4135673
CC	1.3	Transmission	CVT
Fuel Type	Gas	Type of Body	Sedan
Colour	Silver

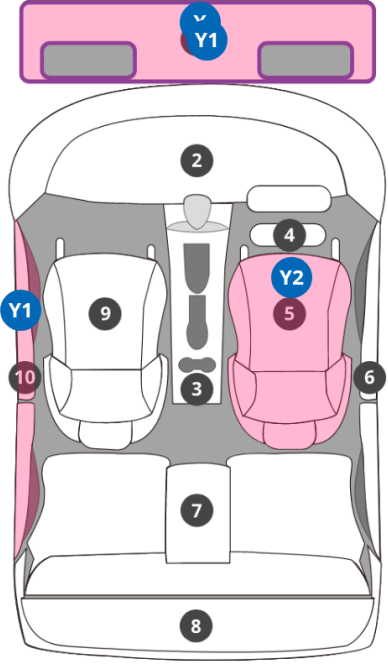
Interior Evaluation : B	Exterior Evaluation : E

<p>a : Cut, Fray d : Loose, Deformed k : Animal Hair s : Smell t : Cigarette Burns x : Defective y : Stain</p>

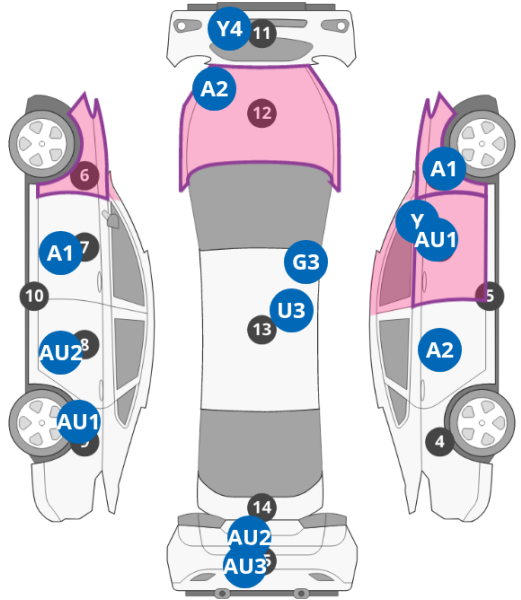
<p>A : Scratch AU : Scratch & Dent B : Modified C : Corrosion G : Stone chip P : Faded S : Rust SC : Rust & Corrosion U : Dent X : Defective Y : Crack, Gap</p>
<p>Remarks Sunvisor, Sunglass Holder - Missing - Yes / Ceiling - Grime - Minimal / (R) Front Seat - Grime - Small / (L) Front Trim - Grime - Minimal</p>	<p>Remarks (R) Front Door - Repair Traces - Yes / (R) Front Fender - Repair Traces - Yes / (L) Front Fender - Repair Traces - Yes / (L) Front Door - Repair Traces - Yes / (L) Rear Door - Repair Traces - Yes / (L) Rear Fender - Repair Traces - Yes / Trunk Hood, Rear Gate - Repair Traces - Yes / (R) Rear Fender - Repair Traces - Yes / (R) Rear Door - Repair Traces - Yes / Roof - Repair Traces - Yes / (R) Front Fender, Molding - Repair mark - Difference in Color / (R) Front Fender, Molding - Scratch - Minimal / (R) Mirror - Crack - Damaged / (R) Front Door, Molding - Repair mark - Difference in Color / (R) Front Door, Molding - Scratch & Dent - Minimal / (R) Rear Door, Molding - Scratch - Small / Trunk Hood, Rear Gate - Scratch & Dent - Small / Rear Bumper, Lamps, Panels - Scratch & Dent - Medium / (L) Rear Fender, Molding - Scratch & Dent - Minimal / (L) Rear Door, Molding - Scratch & Dent - Small / (L) Front Door, Molding - Scratch - Minimal / (L) Front Fender, Molding - Repair mark - Difference in Color / Bonnet, Headlight - Repair mark - Difference in Color / Bonnet, Headlight - Scratch - Small / Front Windshield - Scratch, Stone chip - Medium / Roof - Dent - Medium / Front Bumper, Grille, Lamps - Crack, Gap - Large</p>
