General Information

Make	Toyota	Model	Vios
YOM	2020	Odo Meter Reading	121,037
Registration No.	NGA1790	Chassis No.	PA1B18F30L4117200
CC	1.3	Transmission	CVT
Fuel Type	Gas	Type of Body	Sedan
Colour	Green

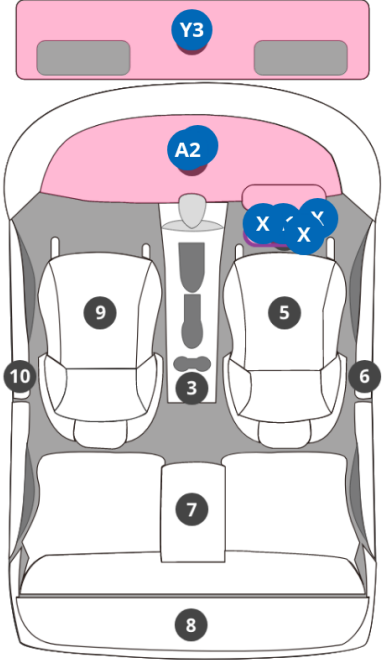
Interior Evaluation : B	Exterior Evaluation : E

<p>a : Cut, Fray d : Loose, Deformed k : Animal Hair s : Smell t : Cigarette Burns x : Defective y : Stain</p>

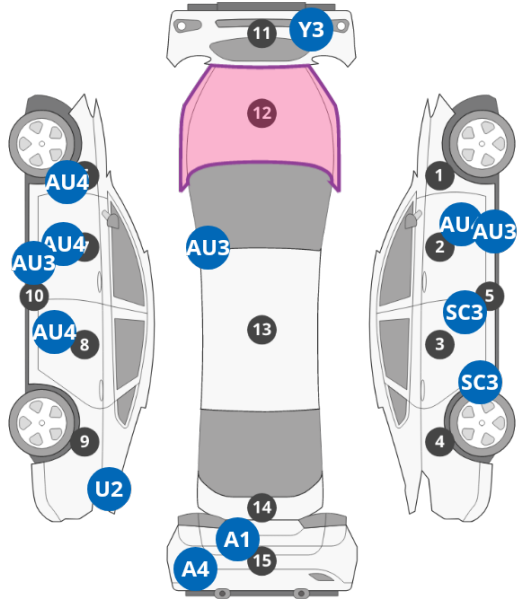
<p>A : Scratch AU : Scratch & Dent B : Modified C : Corrosion G : Stone chip P : Faded S : Rust SC : Rust & Corrosion U : Dent X : Defective Y : Crack, Gap</p>
<p>Remarks Sunvisor, Sunglass Holder - Grime - Medium / Dashboard - Traces of Adhesive Tape - Yes / Carpet - Worn, Scratch, Cut, Crack - Minimal / (R) Front Floor Mat - Missing - Yes / (L) Front Floor Mat - Missing - Yes / Mat Other - Missing - Yes / Steering Wheel - Worn, Peel, Crack - Small</p>	<p>Remarks (R) Front Door - Repair Traces - Yes / (R) Front Fender - Repair Traces - Yes / Bonnet - Repair Traces - Yes / (L) Front Fender - Repair Traces - Yes / (L) Front Door - Repair Traces - Yes / (L) Step - Repair Traces - Yes / (L) Rear Door - Repair Traces - Yes / Trunk Hood, Rear Gate - Repair Traces - Yes / (R) Rear Fender - Repair Traces - Yes / (R) Rear Door - Repair Traces - Yes / Roof - Repair Traces - Yes / (R) Front Door, Molding - Scratch & Dent - Large / (R) Step, In-panel, Side Spoiler - Scratch & Dent - Medium / (R) Rear Door, Molding - Rust, Corrosion - Medium / (R) Rear Fender, Molding - Rust, Corrosion - Medium / Rear Bumper, Lamps, Panels - Scratch - Large / Trunk Hood, Rear Gate - Scratch - Minimal / (L) Rear Fender, Molding - Dent - Small / (L) Rear Door, Molding - Scratch & Dent - Large / (L) Front Door, Molding - Scratch & Dent - Large / (L) Front Fender, Molding - Scratch & Dent - Large / Front Bumper, Grille, Lamps - Crack, Gap - Medium / Bonnet, Headlight - Repair mark - Yes / Roof - Scratch & Dent - Medium / (L) Step, In-panel, Side Spoiler - Scratch & Dent - Medium</p>
