## General Information

<b>Make</b>	Honda	<b>Model</b>	Brio
<b>YOM</b>	2021	<b>Odo Meter Reading</b>	33,297
<b>Registration No.</b>	NEQ6450	<b>Chassis No.</b>	MHRDD1860MJ0772
<b>CC</b>	1.2	<b>Transmission</b>	A/T
<b>Fuel Type</b>	Gas	<b>Type of Body</b>	Hatchback
<b>Colour</b>	Red

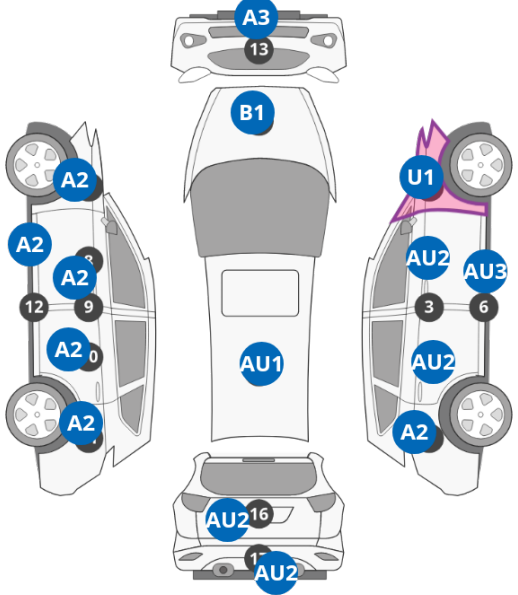
<p><b>A</b> : Scratch <b>AU</b> : Scratch &amp; Dent <b>B</b> : Modified <b>C</b> : Corrosion <b>G</b> : Stone chip <b>P</b> : Faded <b>S</b> : Rust <b>SC</b> : Rust &amp; Corrosion <b>U</b> : Dent <b>X</b> : Defective <b>Y</b> : Crack, Gap</p>
<p><b>Remarks</b> (L) Front Trim - Grime - Minimal / (R) Front Trim - Grime - Minimal / (L) Front Seat - Grime - Small / (R) Front Seat - Grime - Small / (R) Front Floor Mat - Grime - Small / (L) Front Floor Mat - Grime - Medium / Mat Other - Grime - Small / Rear Seat - Grime - Small / Trunk Room - Worked - Minimal / Console, Switches, Vents - Worked - Minimal / Ceiling - Grime - Minimal</p>	<p><b>Remarks</b> (R) Front Door - Repair Traces - Yes / (R) Rear Door - Repair Traces - Yes / Roof - Scratch &amp; Dent - Minimal / (L) Rear Door, Molding - Scratch - Small / (L) Rear Fender, Molding - Scratch - Small / (L) Step, In-panel, Side Spoiler - Scratch - Small / (L) Front Door, Molding - Scratch - Small / (L) Front Fender, Molding - Scratch - Small / Bonnet, Headlight - Modified - Minimal / (R) Front Fender, Molding - Repair mark - Yes / (R) Front Fender, Molding - Dent - Minimal / (R) Front Door, Molding - Scratch &amp; Dent - Small / (R) Step, In-panel, Side Spoiler - Scratch &amp; Dent - Medium / (R) Rear Door, Molding - Scratch &amp; Dent - Small / (R) Rear Fender, Molding - Scratch - Small / Trunk Hood, Rear Gate - Scratch &amp; Dent - Small / Rear Bumper, Lamps, Panels - Scratch &amp; Dent - Small / Front Bumper, Grille, Lamps - Scratch - Medium</p>
