## General Information

Date & Time: 13, Jan, 2026 16:02

<b>Make</b>	Isuzu	<b>Model</b>	D-MAX
<b>YOM</b>	2015	<b>Odo Meter Reading</b>	115,599
<b>Registration No.</b>	AMA7793	<b>Chassis No.</b>	PABTFR86HE2000680
<b>CC</b>	2.5	<b>Transmission</b>	M/T
<b>Fuel Type</b>	Diesel	<b>Type of Body</b>	Pickup
<b>Colour</b>	Silver

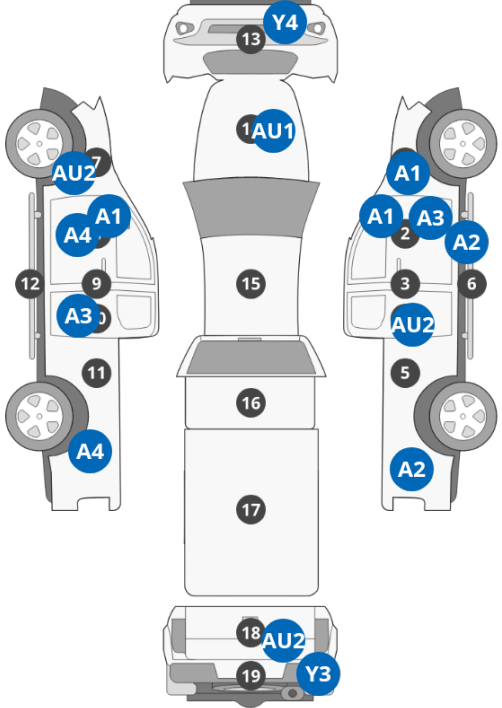
<p><b>A</b> : Scratch <b>AU</b> : Scratch &amp; Dent <b>B</b> : Modified <b>C</b> : Corrosion <b>G</b> : Stone chip <b>P</b> : Faded <b>S</b> : Rust <b>SC</b> : Rust &amp; Corrosion <b>U</b> : Dent <b>X</b> : Defective <b>Y</b> : Crack, Gap</p>
<p><b>Remarks</b> Overall Interior - Worn as per age - Yes / (R) Front Floor Mat - Missing - Yes / (L) Front Floor Mat - Missing - Yes / Mat Other - Missing - Yes / (L) Front Seat - Cut, Crack - Small / Steering Wheel - Worn, Peel, Crack - Medium</p>	<p><b>Remarks</b> (R) Front Door - Repair Traces - Yes / (R) Step - Repair Traces - Yes / (R) Front Fender - Repair Traces - Yes / Bonnet - Repair Traces - Yes / (L) Front Fender - Repair Traces - Yes / (L) Front Door - Repair Traces - Yes / (L) Rear Door - Repair Traces - Yes / (L) Rear Corner Panel - Repair Traces - Yes / (R) Rear Door - Repair Traces - Yes / Roof - Repair Traces - Yes / (R) Front Fender, Molding - Scratch - Minimal / (R) Mirror - Scratch - Minimal / (R) Front Door, Molding - Scratch - Medium / (R) Step, In-panel, Side Spoiler - Scratch - Small / (R) Rear Door, Molding - Scratch &amp; Dent - Small / (R) Side Gate - Scratch - Small / Rear Bumper, Lamps, Panels - Crack, Gap - Medium / Rear Gate - Scratch &amp; Dent - Small / (L) Side Gate - Scratch - Large / (L) Rear Door, Molding - Scratch - Medium / (L) Front Door, Molding - Scratch - Large / (L) Front Fender, Molding - Scratch &amp; Dent - Small / Front Bumper, Grille, Lamps - Crack, Gap - Large / Bonnet, Headlight - Scratch &amp; Dent - Minimal / Overall Exterior - Full Re-Paint in same color - Yes / (L) Mirror - Scratch - Minimal</p>
