## General Information

<b>Make</b>	Toyota	<b>Model</b>	Vios
<b>YOM</b>	2024	<b>Odo Meter Reading</b>	18,076
<b>Registration No.</b>	DBN5084	<b>Chassis No.</b>	PA1B18F31P4228960
<b>CC</b>	1.3	<b>Transmission</b>	CVT
<b>Fuel Type</b>	Gas	<b>Type of Body</b>	Sedan
<b>Colour</b>	Green

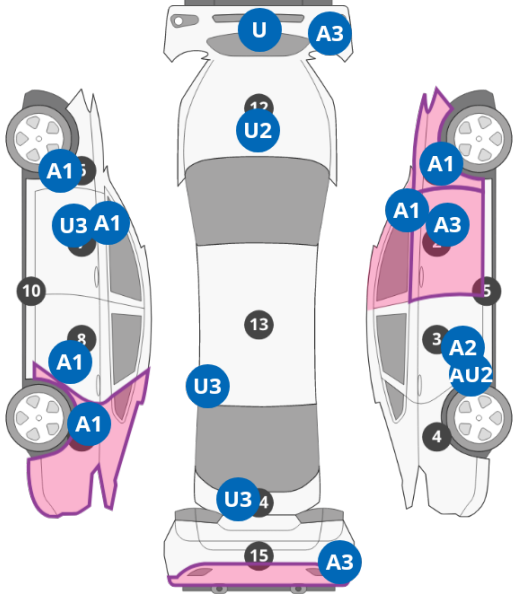
<p><b>A</b> : Scratch <b>AU</b> : Scratch &amp; Dent <b>B</b> : Modified <b>C</b> : Corrosion <b>G</b> : Stone chip <b>P</b> : Faded <b>S</b> : Rust <b>SC</b> : Rust &amp; Corrosion <b>U</b> : Dent <b>X</b> : Defective <b>Y</b> : Crack, Gap</p>
<p><b>Remarks</b> Dashboard - Traces of Adhesive Tape - Yes / (L) Front Seat - Worn - Yes / (R) Front Seat - Grime - Medium / Rear Seat - Grime - Medium / (L) Front Seat - Cigarette Burns - Burnt Minimal / Ceiling - Grime - Minimal / (R) Front Trim - Grime - Small / (L) Front Trim - Grime - Minimal / (L) Front Floor Mat - Worked - Small</p>	<p><b>Remarks</b> Member (Bolted) - Dent - Yes / (R) Front Door, Molding - Repair mark - Yes / (R) Front Door, Molding - Scratch - Medium / (R) Mirror - Scratch - Minimal / (R) Front Wheel, Cover - Cap Missing - Yes / (R) Front Fender, Molding - Scratch - Minimal / (R) Rear Fender, Molding - Scratch &amp; Dent - Small / (R) Rear Door, Molding - Scratch - Small / Rear Bumper, Lamps, Panels - Repair mark - Yes / Rear Bumper, Lamps, Panels - Scratch - Medium / Trunk Hood, Rear Gate - Dent - Medium / (L) Rear Fender, Molding - Scratch - Minimal / (L) Front Door, Molding - Dent - Medium / (L) Rear Door, Molding - Scratch - Minimal / (L) Mirror - Scratch - Minimal / (L) Front Fender, Molding - Scratch - Minimal / Front Bumper, Grille, Lamps - Scratch - Medium / Bonnet, Headlight - Dent - Small / Roof - Dent - Medium / (L) Rear Fender, Molding - Repair mark - Yes</p>
