General Information

Make	Toyota	Model	Yaris
YOM	2017	Odo Meter Reading	93,921
Registration No.	DAE7761	Chassis No.	MR2K29F37H1073499
CC	1.5	Transmission	A/T
Fuel Type	Gas	Type of Body	Hatchback
Colour	Black

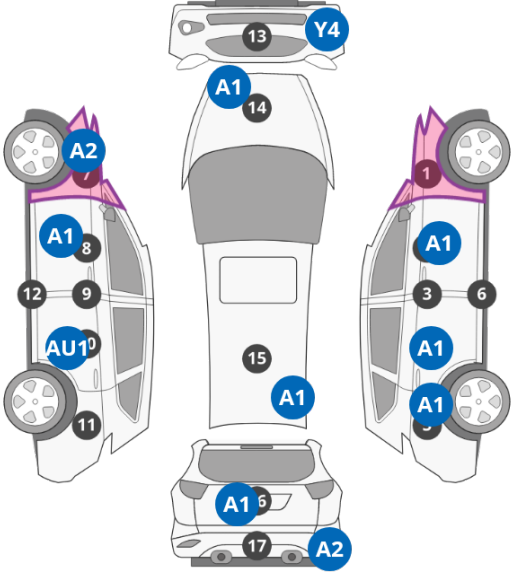
<p>A : Scratch AU : Scratch & Dent B : Modified C : Corrosion G : Stone chip P : Faded S : Rust SC : Rust & Corrosion U : Dent X : Defective Y : Crack, Gap</p>
Remarks Defects not found	Remarks (R) Front Door - Repair Traces - Yes / (R) Step - Repair Traces - Yes / (R) Front Fender - Repair Traces - Yes / Bonnet - Repair Traces - Yes / (L) Front Fender - Repair Traces - Yes / (L) Front Door - Repair Traces - Yes / (L) Rear Door - Repair Traces - Yes / (L) Rear Fender - Repair Traces - Yes / Trunk Hood, Rear Gate - Repair Traces - Yes / (R) Rear Door - Repair Traces - Yes / Roof - Repair Traces - Yes / Overall Exterior - Full Re-Paint in same color - Yes / (R) Front Fender, Molding - Repair mark - Yes / (R) Front Door, Molding - Scratch - Minimal / (R) Rear Door, Molding - Scratch - Minimal / (R) Rear Fender, Molding - Scratch - Minimal / Rear Bumper, Lamps, Panels - Scratch - Small / Trunk Hood, Rear Gate - Scratch - Minimal / (L) Rear Door, Molding - Scratch & Dent - Minimal / (L) Front Door, Molding - Scratch - Minimal / (L) Front Fender, Molding - Repair mark - Yes / (L) Front Fender, Molding - Scratch - Small / Front Bumper, Grille, Lamps - Crack, Gap - Large / Roof - Scratch - Minimal / Bonnet, Headlight - Scratch - Minimal
