## General Information

Date & Time: 13, Jan, 2026 15:59

<b>Make</b>	MG	<b>Model</b>	ZS
<b>YOM</b>	2022	<b>Odo Meter Reading</b>	32,621
<b>Registration No.</b>	NIH5376	<b>Chassis No.</b>	LSJW7496NZ170534
<b>CC</b>	1.3	<b>Transmission</b>	A/T
<b>Fuel Type</b>	Gas	<b>Type of Body</b>	SUV
<b>Colour</b>	Black

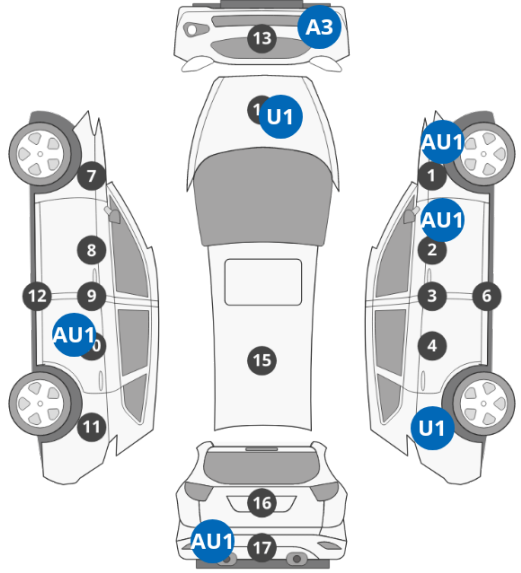
<b>Interior Evaluation :</b>	<b>A</b>	<b>Exterior Evaluation :</b>	<b>B</b>

<p><b>a</b> : Cut, Fray <b>d</b> : Loose, Deformed <b>k</b> : Animal Hair <b>s</b> : Smell <b>t</b> : Cigarette Burns <b>x</b> : Defective <b>y</b> : Stain</p>		<p><b>A</b> : Scratch <b>AU</b> : Scratch &amp; Dent <b>B</b> : Modified <b>C</b> : Corrosion <b>G</b> : Stone chip <b>P</b> : Faded <b>S</b> : Rust <b>SC</b> : Rust &amp; Corrosion <b>U</b> : Dent <b>X</b> : Defective <b>Y</b> : Crack, Gap</p>	
<p><b>Remarks</b> Defects not found</p>		<p><b>Remarks</b> Bonnet - Repair Traces - Yes / (R) Front Fender, Molding - Scratch &amp; Dent - Minimal / (R) Front Door, Molding - Scratch &amp; Dent - Minimal / (R) Rear Fender, Molding - Dent - Minimal / Rear Bumper, Lamps, Panels - Scratch &amp; Dent - Minimal / (L) Rear Door, Molding - Scratch &amp; Dent - Minimal / Front Bumper, Grille, Lamps - Scratch - Medium / Bonnet, Headlight - Dent - Minimal</p>

<b>Inspector Notes</b>
<p>With Lto plate, with warranty booklet, with spare tire and jack, 1key, no tools, scratches on headlights and taillights,</p>
