General Information

| Make | Toyota | Model | Vios |

Body / Panel Condition

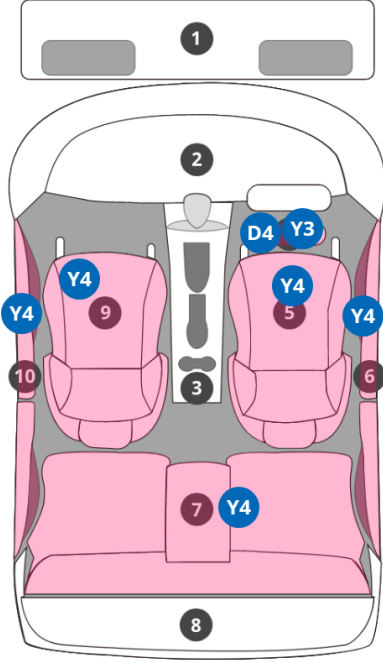
| Interior Evaluation : E | Exterior Evaluation : C |

| <p>Remarks Rear Seat - Grime - Large / (R) Front Trim - Grime - Large / (R) Front Seat - Grime - Large / (R) Front Floor Mat - Grime - Medium / (L) Front Floor Mat - Worked - Large / (L) Front Seat - Grime - Large / (L) Front Trim - Grime - Large</p> | <p>Remarks (R) Front Door, Molding - Dent - Small / Trunk Hood, Rear Gate - Dent - Small / Rear Bumper, Lamps, Panels - Scratch - Medium / Front Bumper, Grille, Lamps - Scratch - Large / Bonnet, Headlight - Dent - Small / Roof - Dent - Small / (R) Rear Fender, Molding - Scratch - Minimal / (R) Front Fender, Molding - Scratch - Minimal / (L) Rear Door, Molding - Scratch - Minimal / (L) Front Door, Molding - Scratch - Minimal / (L) Front Fender, Molding - Scratch - Minimal</p> |
