## General Information

Date & Time: 14, Jan, 2026 11:24

<b>Make</b>	Ford	<b>Model</b>	Everest
<b>YOM</b>	2020	<b>Odo Meter Reading</b>	21,367
<b>Registration No.</b>	ZAB4713	<b>Chassis No.</b>	MNCAXXMAWALB91737
<b>CC</b>	2.0	<b>Transmission</b>	A/T
<b>Fuel Type</b>	Diesel	<b>Type of Body</b>	Wagon
<b>Colour</b>	White

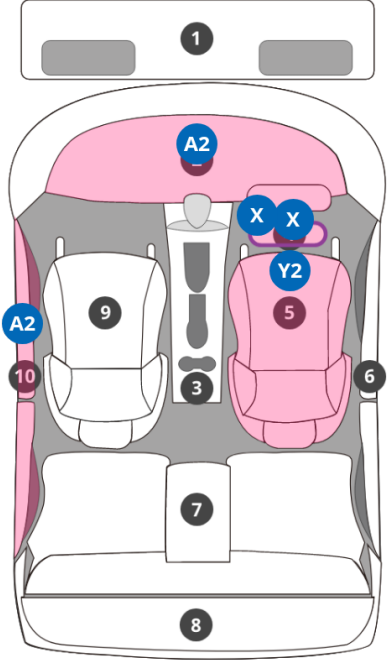
<b>Interior Evaluation :</b> <span style="float: right; color: red; font-weight: bold;">B</span>	<b>Exterior Evaluation :</b> <span style="float: right; color: red; font-weight: bold;">D</span>

<p><b>a</b> : Cut, Fray <b>d</b> : Loose, Deformed <b>k</b> : Animal Hair <b>s</b> : Smell <b>t</b> : Cigarette Burns <b>x</b> : Defective <b>y</b> : Stain</p>

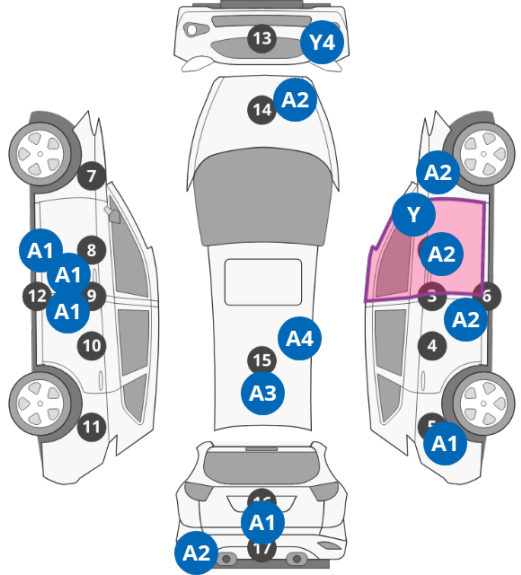
<p><b>A</b> : Scratch <b>AU</b> : Scratch &amp; Dent <b>B</b> : Modified <b>C</b> : Corrosion <b>G</b> : Stone chip <b>P</b> : Faded <b>S</b> : Rust <b>SC</b> : Rust &amp; Corrosion <b>U</b> : Dent <b>X</b> : Defective <b>Y</b> : Crack, Gap</p>
<p><b>Remarks</b> (L) Front Trim - Cut, Crack - Small / Mat Other - Missing - Yes / (R) Front Floor Mat - Missing - Yes / (R) Front Seat - Grime - Small / Dashboard - Worn, Scratch, Cut, Crack - Small</p>	<p><b>Remarks</b> (R) Front Door - Repair Traces - Yes / (R) Front Fender - Repair Traces - Yes / Bonnet - Repair Traces - Yes / (L) Front Fender - Repair Traces - Yes / (L) Front Door - Repair Traces - Yes / (L) Rear Door - Repair Traces - Yes / (L) Rear Fender - Repair Traces - Yes / Trunk Hood, Rear Gate - Repair Traces - Yes / (R) Rear Fender - Repair Traces - Yes / (R) Rear Door - Repair Traces - Yes / Roof - Repair Traces - Yes / Overall Exterior - Full Re-Paint in same color - Yes / (R) Front Door, Molding - Repair mark - Yes / (R) Front Fender, Molding - Scratch - Small / (R) Mirror - Crack - Cracks / (R) Front Door, Molding - Scratch - Small / (R) Rear Door, Molding - Scratch - Small / (R) Rear Fender, Molding - Scratch - Minimal / Rear Bumper, Lamps, Panels - Scratch - Small / Trunk Hood, Rear Gate - Scratch - Minimal / Roof Spoiler, Molding - Scratch - Medium / Roof - Scratch - Large / (L) Rear Door, Molding - Scratch - Minimal / (L) Step, In-panel, Side Spoiler - Scratch - Minimal / (L) Front Door, Molding - Scratch - Minimal / Front Bumper, Grille, Lamps - Crack, Gap - Large / Bonnet, Headlight - Scratch - Small</p>
