## General Information

<b>Make</b>	Toyota	<b>Model</b>	Avanza
<b>YOM</b>	2025	<b>Odo Meter Reading</b>	79,803
<b>Registration No.</b>	FAS1282	<b>Chassis No.</b>	MHFAA1BY7R0030348
<b>CC</b>	1.3	<b>Transmission</b>	M/T
<b>Fuel Type</b>	Gas	<b>Type of Body</b>	MPV
<b>Colour</b>	White

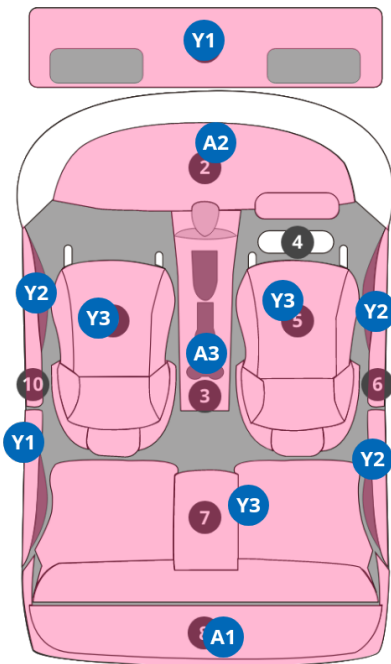
<b>Interior Evaluation :</b> <span style="float: right; color: red; font-weight: bold;">C</span>	<b>Exterior Evaluation :</b> <span style="float: right; color: red; font-weight: bold;">E</span>

<p><b>a</b> : Cut, Fray <b>d</b> : Loose, Deformed <b>k</b> : Animal Hair <b>s</b> : Smell <b>t</b> : Cigarette Burns <b>x</b> : Defective <b>y</b> : Stain</p>

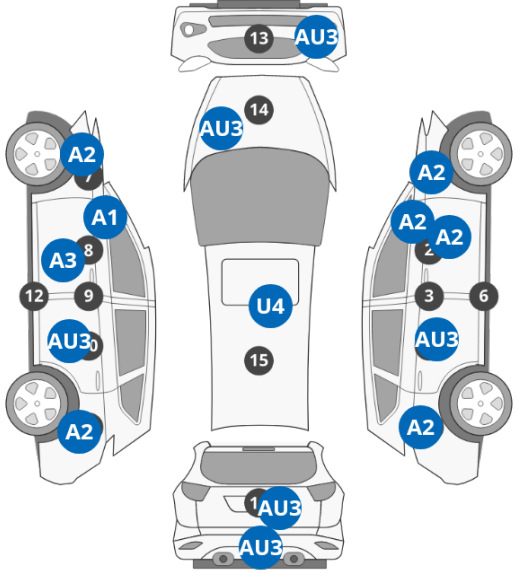
<p><b>A</b> : Scratch <b>AU</b> : Scratch &amp; Dent <b>B</b> : Modified <b>C</b> : Corrosion <b>G</b> : Stone chip <b>P</b> : Faded <b>S</b> : Rust <b>SC</b> : Rust &amp; Corrosion <b>U</b> : Dent <b>X</b> : Defective <b>Y</b> : Crack, Gap</p>
<p><b>Remarks</b> (R) Front Seat - Grime - Medium / Rear Seat - Grime - Medium / (R) Front Trim - Grime - Small / (R) Rear Trim - Grime - Small / Trunk Room - Worn, Scratch, Cut, Crack - Minimal / (L) Rear Trim - Grime - Minimal / (L) Front Trim - Grime - Small / (L) Front Seat - Grime - Medium / Console, Switchs, Vents - Worn, Scratch, Cut, Crack - Medium / Dashboard - Worn, Scratch, Cut, Crack - Small / Ceiling - Grime - Minimal</p>	<p><b>Remarks</b> (L) Rear Door, Molding - Scratch &amp; Dent - Medium / (L) Mirror - Scratch - Minimal / (L) Front Door, Molding - Scratch - Medium / (L) Front Fender, Molding - Scratch - Small / Bonnet, Headlight - Scratch &amp; Dent - Medium / Front Bumper, Grille, Lamps - Scratch &amp; Dent - Medium / (R) Mirror - Scratch - Small / (R) Front Fender, Molding - Scratch - Small / (R) Front Door, Molding - Scratch - Small / Roof - Dent - Large / (R) Rear Door, Molding - Scratch &amp; Dent - Medium / (R) Rear Fender, Molding - Scratch - Small / Trunk Hood, Rear Gate - Scratch &amp; Dent - Medium / Rear Bumper, Lamps, Panels - Scratch &amp; Dent - Medium / (L) Rear Fender, Molding - Scratch - Small</p>
