General Information

| Make | Mitsubishi | Model | Mirage |
| YOM | 2019 | Odo Meter Reading | 54,629 |
| Registration No. | NFT3277 | Chassis No. | PAEA13TJKK01596 |

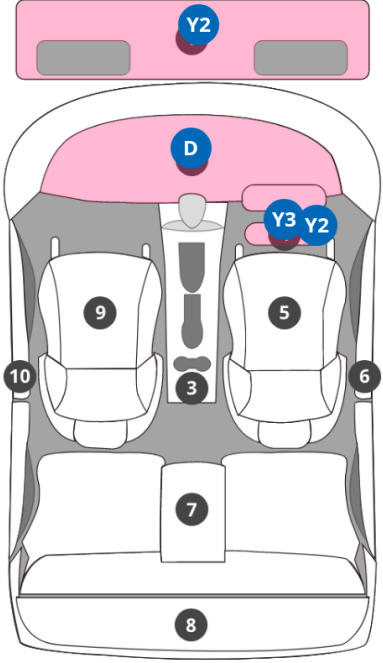
| <p>Remarks Sunvisor, Sunglass Holder - Grime - Small / (R) Front Floor Mat - Grime - Medium / Dashboard - Traces of Adhesive Tape - Yes / (L) Front Floor Mat - Grime - Small</p> | <p>Remarks (R) Front Door - Repair Traces - Yes / (R) Step - Repair Traces - Yes / (R) Front Fender - Repair Traces - Yes / Bonnet - Repair Traces - Yes / (L) Front Fender - Repair Traces - Yes / (L) Front Door - Repair Traces - Yes / (L) Rear Door - Repair Traces - Yes / (L) Rear Fender - Repair Traces - Yes / Trunk Hood, Rear Gate - Repair Traces - Yes / (R) Rear Fender - Repair Traces - Yes / (R) Rear Door - Repair Traces - Yes / Roof - Repair Traces - Yes / Overall Exterior - Full Re-Paint in same color - Yes / (R) Front Fender, Molding - Dent - Minimal / (R) Mirror - Scratch - Minimal / (R) Front Door, Molding - Scratch - Minimal / (R) Rear Door, Molding - Scratch & Dent - Minimal / Trunk Hood, Rear Gate - Crack, Gap - Medium / Rear Bumper, Lamps, Panels - Crack, Gap - Small / Rear Bumper, Lamps, Panels - Repair mark - Difference in Color / (L) Rear Fender, Molding - Dent - Medium / (L) Rear Door, Molding - Scratch - Minimal / Roof - Dent - Small / (L) Mirror - Scratch, Peeled - Minimal / (L) Step, In-panel, Side Spoiler - Dent - Small / (L) Front Door, Molding - Scratch & Dent - Minimal / (L) Front Fender, Molding - Dent - Minimal / Front Bumper, Grille, Lamps - Crack, Gap - Small</p> |
