General Information

| Make | Mitsubishi | Model | Montero SPT |
| Registration No. | NDF6776 | Chassis No. | MMBGUKR10GH001715 |

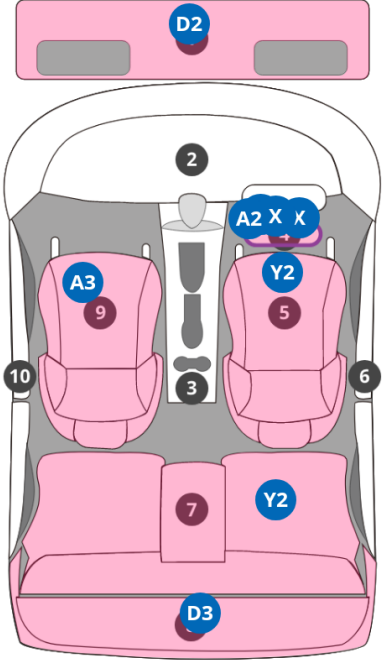
| Interior Evaluation : B | Exterior Evaluation : E |

| <p>Remarks (R) Front Floor Mat - Missing - Yes / (L) Front Floor Mat - Missing - Yes / Mat Other - Missing - Yes / Ceiling - Loose, Deformed - Small / (R) Front Seat - Grime - Small / Rear Seat - Grime - Small / Trunk Room - Loose, Deformed - Medium / (L) Front Seat - Cut, Crack - Medium</p> | <p>Remarks Bonnet - Repair Traces - Yes / (R) Front Fender, Molding - Scratch - Minimal / (R) Front Door, Molding - Scratch & Dent - Minimal / (R) Step, In-panel, Side Spoiler - Scratch & Dent - Large / (R) Rear Door, Molding - Scratch & Dent - Large / (R) Rear Fender, Molding - Scratch - Scratch & Dent - Small / Trunk Hood, Rear Gate - Scratch - Minimal / (L) Rear Fender, Molding - Scratch & Dent - Medium / (L) Rear Door, Molding - Scratch - Small / (L) Step, In-panel, Side Spoiler - Scratch - Small / (L) Front Door, Molding - Scratch - Small / (L) Front Fender, Molding - Scratch - Minimal / Front Bumper, Grille, Lamps - Crack, Gap - Large / Bonnet, Headlight - Repair mark - Yes / Roof - Dent - Minimal / Rear Bumper, Lamps, Panels - Scratch & Dent - Large</p> |
