General Information

Make	Isuzu	Model	Crosswind
YOM	2015	Odo Meter Reading	142,064
Registration No.	AMA8917	Chassis No.	PABTBR54FF2083312
CC	2.5	Transmission	M/T
Fuel Type	Diesel	Type of Body	Wagon
Colour	Beige

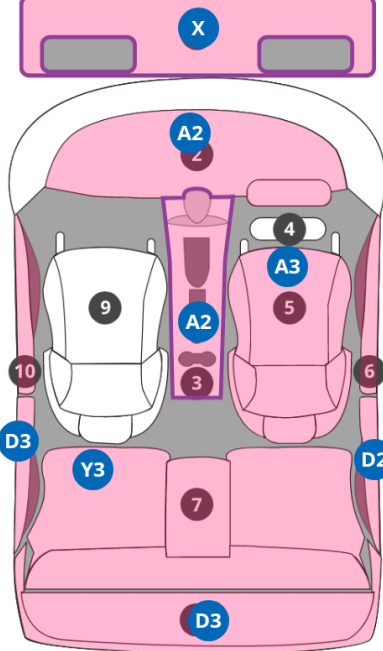
Interior Evaluation : C	Exterior Evaluation : E

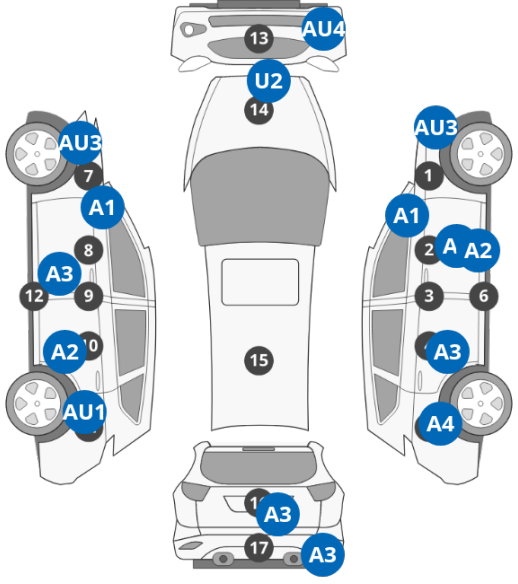
<p>A : Scratch AU : Scratch & Dent B : Modified C : Corrosion G : Stone chip P : Faded S : Rust SC : Rust & Corrosion U : Dent X : Defective Y : Crack, Gap</p>
Remarks Sunvisor, Sunglass Holder - Missing - Yes / Display, Audio System - Missing - Yes / (R) Front Seat - Cut, Crack - Medium / Rear Seat - Grime - Medium / (L) Rear Trim - Loose, Deformed - Medium / (R) Rear Trim - Loose, Deformed - Small / Trunk Room - Loose, Deformed - Medium / Knobs - Worn, Peel, Crack - Small / Room Lamp - Missing - Yes / Steering Wheel - Worn, Peel, Crack - Small	Remarks Bonnet - Repair Traces - Yes / (R) Front Fender, Molding - Scratch & Dent - Medium / (R) Mirror - Scratch - Minimal / (R) Front Door, Molding - Scratch - Minimal / (R) Step, In-panel, Side Spoiler - Scratch - Small / (R) Rear Door, Molding - Scratch - Medium / (R) Rear Fender, Molding - Scratch - Large / Rear Bumper, Lamps, Panels - Scratch - Medium / Trunk Hood, Rear Gate - Scratch - Medium / (L) Rear Fender, Molding - Scratch & Dent - Minimal / (L) Rear Door, Molding - Scratch - Small / (L) Front Door, Molding - Scratch - Medium / (L) Mirror - Scratch, Peeled - Minimal / (L) Front Fender, Molding - Scratch & Dent - Medium / Front Bumper, Grille, Lamps - Scratch & Dent - Large / Bonnet, Headlight - Dent - Small
