General Information

Date & Time: 15, Jan, 2026 10:20

Make	Mitsubishi	Model	Mirage
YOM	2023	Odo Meter Reading	46,115
Registration No.	DAS9721	Chassis No.	PAEA13MJPNA015108
CC	1.2	Transmission	M/T
Fuel Type	Gas	Type of Body	Sedan
Colour	Gray

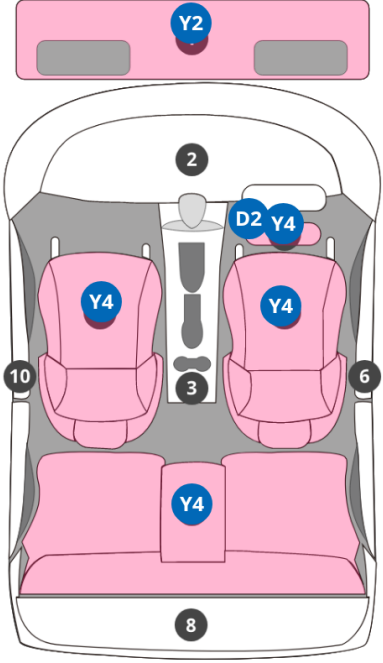
Interior Evaluation : C	Exterior Evaluation : E

<p>a : Cut, Fray d : Loose, Deformed k : Animal Hair s : Smell t : Cigarette Burns x : Defective y : Stain</p>

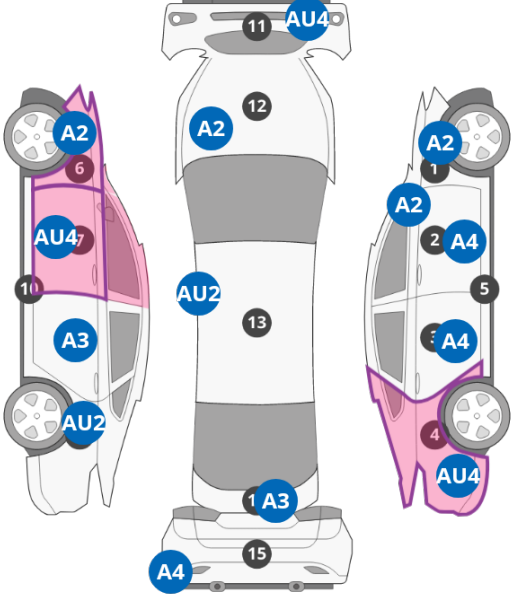
<p>A : Scratch AU : Scratch & Dent B : Modified C : Corrosion G : Stone chip P : Faded S : Rust SC : Rust & Corrosion U : Dent X : Defective Y : Crack, Gap</p>
<p>Remarks (L) Front Seat - Grime - Large / (L) Front Floor Mat - Worked - Small / Rear Seat - Grime - Large / Mat Other - Grime - Large / Ceiling - Grime - Small / (R) Front Seat - Grime - Large</p>	<p>Remarks (R) Step - Repair Traces - Yes / (L) Front Fender - Repair Traces - Yes / (L) Front Door - Repair Traces - Yes / (L) Step - Repair Traces - Yes / (L) Rear Fender - Repair Traces - Yes / (L) Front Door, Molding - Repair mark - Yes / (L) Front Door, Molding - Scratch & Dent - Large / (L) Rear Door, Molding - Scratch - Medium / (L) Rear Fender, Molding - Scratch & Dent - Small / (R) Rear Fender, Molding - Scratch & Dent - Large / Rear Bumper, Lamps, Panels - Scratch - Large / (R) Rear Door, Molding - Scratch - Large / (R) Front Door, Molding - Scratch - Large / (R) Mirror - Scratch - Small / (R) Front Fender, Molding - Scratch - Small / Overall Exterior - Faded(Color, Gloss) - Yes / Front Bumper, Grille, Lamps - Scratch & Dent - Large / Bonnet, Headlight - Scratch - Small / (L) Front Fender, Molding - Scratch - Small / Roof - Scratch & Dent - Small / Trunk Hood, Rear Gate - Scratch - Medium / (R) Rear Wheel, Cover - Cap Missing - Yes / (L) Front Wheel, Cover - Cap Missing - Yes</p>
