## General Information

Date & Time: 15, Jan, 2026 14:00

<b>Make</b>	Toyota	<b>Model</b>	Vios
<b>YOM</b>	2021	<b>Odo Meter Reading</b>	106,339
<b>Registration No.</b>	NEW4076	<b>Chassis No.</b>	PA1B18F3844169256
<b>CC</b>	1.3	<b>Transmission</b>	CVT
<b>Fuel Type</b>	Gas	<b>Type of Body</b>	Sedan
<b>Colour</b>	Silver

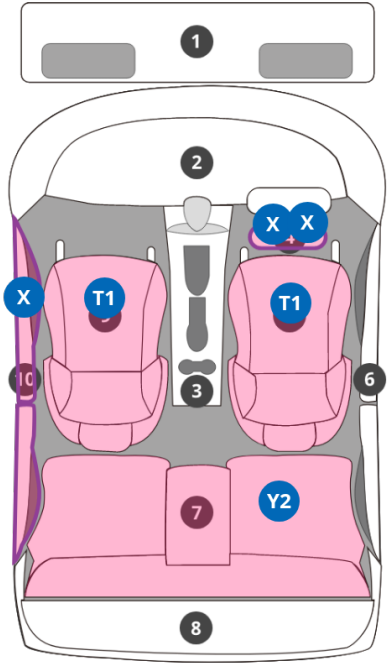
<p><b>A</b> : Scratch <b>AU</b> : Scratch &amp; Dent <b>B</b> : Modified <b>C</b> : Corrosion <b>G</b> : Stone chip <b>P</b> : Faded <b>S</b> : Rust <b>SC</b> : Rust &amp; Corrosion <b>U</b> : Dent <b>X</b> : Defective <b>Y</b> : Crack, Gap</p>
<p><b>Remarks</b> (R) Front Seat - Cigarette Burns - Burnt Minimal / (L) Front Seat - Cigarette Burns - Burnt Minimal / Rear Seat - Grime - Small / (L) Front Floor Mat - Missing - Yes / Mat Other - Missing - Yes / (L) Front Trim - Missing - Yes</p>	<p><b>Remarks</b> (R) Mirror - Scratch - Minimal / (R) Front Door, Molding - Scratch &amp; Dent - Medium / (R) Rear Door, Molding - Scratch &amp; Dent - Medium / (R) Step, In-panel, Side Spoiler - Scratch &amp; Dent - Large / (R) Rear Fender, Molding - Scratch &amp; Dent - Minimal / Rear Bumper, Lamps, Panels - Scratch &amp; Dent - Medium / Trunk Hood, Rear Gate - Scratch &amp; Dent - Small / (L) Rear Fender, Molding - Scratch - Minimal / (L) Front Door, Molding - Scratch &amp; Dent - Small / (L) Front Fender, Molding - Scratch &amp; Dent - Medium / Front Bumper, Grille, Lamps - Scratch &amp; Dent - Large / Bonnet, Headlight - Scratch &amp; Dent - Small / Front Windshield - Scratch, Stone chip - Small</p>
