## General Information

<b>Make</b>	Nissan	<b>Model</b>	Navara
<b>YOM</b>	2024	<b>Odo Meter Reading</b>	40,260
<b>Registration No.</b>	NFS6704	<b>Chassis No.</b>	MNTCCAD23Z0021233
<b>CC</b>	2.5	<b>Transmission</b>	M/T
<b>Fuel Type</b>	Diesel	<b>Type of Body</b>	Pickup
<b>Colour</b>	Silver

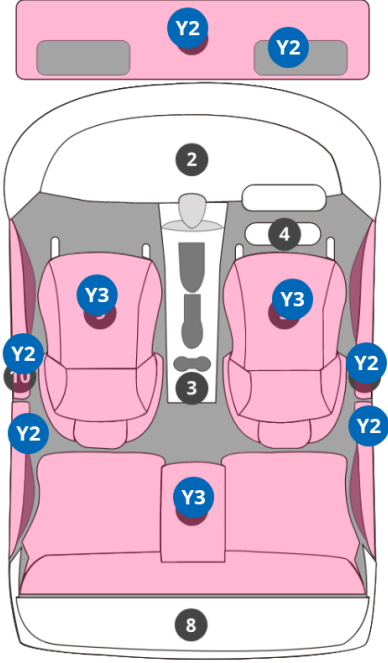
<b>Interior Evaluation :</b> <span style="float: right; color: red; font-weight: bold;">C</span>	<b>Exterior Evaluation :</b> <span style="float: right; color: red; font-weight: bold;">D</span>

<p><b>a</b> : Cut, Fray <b>d</b> : Loose, Deformed <b>k</b> : Animal Hair <b>s</b> : Smell <b>t</b> : Cigarette Burns <b>x</b> : Defective <b>y</b> : Stain</p>

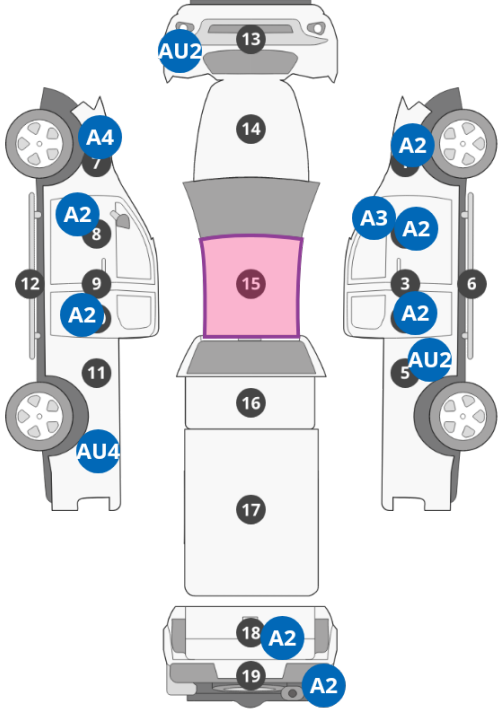
<p><b>A</b> : Scratch <b>AU</b> : Scratch &amp; Dent <b>B</b> : Modified <b>C</b> : Corrosion <b>G</b> : Stone chip <b>P</b> : Faded <b>S</b> : Rust <b>SC</b> : Rust &amp; Corrosion <b>U</b> : Dent <b>X</b> : Defective <b>Y</b> : Crack, Gap</p>
<p><b>Remarks</b> (R) Front Trim - Grime - Small / (R) Front Seat - Grime - Medium / Sunvisor, Sunglass Holder - Grime - Small / Ceiling - Grime - Small / Rear Seat - Grime - Medium / (L) Rear Trim - Grime - Small / (R) Rear Trim - Grime - Small / (L) Front Trim - Grime - Small / (L) Front Seat - Grime - Medium</p>	<p><b>Remarks</b> (L) Front Fender, Molding - Scratch - Large / (L) Front Door, Molding - Scratch - Small / (L) Rear Door, Molding - Scratch - Small / (L) Side Gate - Scratch &amp; Dent - Large / Rear Gate - Scratch - Small / Rear Bumper, Lamps, Panels - Scratch - Small / (R) Side Gate - Scratch &amp; Dent - Small / (R) Rear Door, Molding - Scratch - Small / (R) Front Door, Molding - Scratch - Small / (R) Mirror - Scratch - Medium / (R) Front Fender, Molding - Scratch - Small / Front Bumper, Grille, Lamps - Scratch &amp; Dent - Small / Roof - Repair mark - Yes</p>
