## General Information

<b>Make</b>	Toyota	<b>Model</b>	Fortuner
<b>YOM</b>	2023	<b>Odo Meter Reading</b>	26,448
<b>Registration No.</b>	NHJ6744	<b>Chassis No.</b>	MHFAA8GS4P0903371
<b>CC</b>	2.8	<b>Transmission</b>	A/T
<b>Fuel Type</b>	Diesel	<b>Type of Body</b>	SUV
<b>Colour</b>	Black

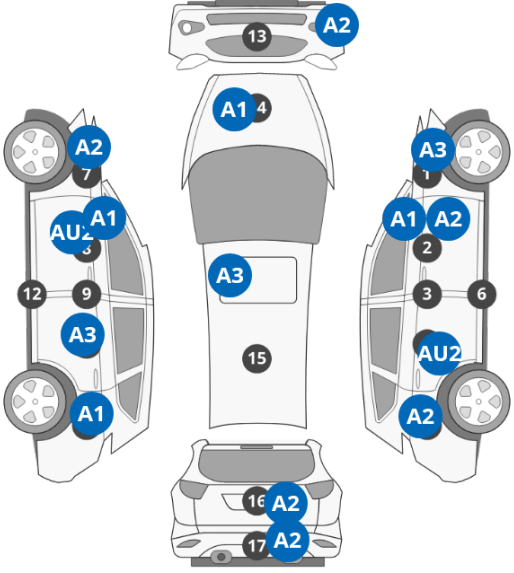
<p><b>A</b> : Scratch <b>AU</b> : Scratch &amp; Dent <b>B</b> : Modified <b>C</b> : Corrosion <b>G</b> : Stone chip <b>P</b> : Faded <b>S</b> : Rust <b>SC</b> : Rust &amp; Corrosion <b>U</b> : Dent <b>X</b> : Defective <b>Y</b> : Crack, Gap</p>
<p><b>Remarks</b> (L) Front Seat - Worn - Yes / (L) Front Floor Mat - Worked - Small / Ceiling - Grime - Minimal</p>	<p><b>Remarks</b> (R) Front Fender, Molding - Scratch - Medium / (R) Front Door, Molding - Scratch - Small / (R) Mirror - Scratch - Minimal / (R) Rear Door, Molding - Scratch &amp; Dent - Small / (R) Rear Fender, Molding - Scratch - Small / Rear Bumper, Lamps, Panels - Scratch - Small / Trunk Hood, Rear Gate - Scratch - Small / (L) Rear Door, Molding - Scratch - Medium / (L) Rear Fender, Molding - Scratch - Minimal / (L) Front Door, Molding - Scratch &amp; Dent - Small / (L) Mirror - Scratch - Minimal / (L) Front Fender, Molding - Scratch - Small / Front Bumper, Grille, Lamps - Scratch - Small / Bonnet, Headlight - Scratch - Minimal / Roof - Scratch - Medium</p>
