## General Information

Date & Time: 16, Jan, 2026 12:36

<b>Make</b>	Toyota	<b>Model</b>	Hilux Tamaraw
<b>YOM</b>	2025	<b>Odo Meter Reading</b>	8,146
<b>Registration No.</b>	NKS2854	<b>Chassis No.</b>	PAHACACA2S6426476
<b>CC</b>	2.4	<b>Transmission</b>	M/T
<b>Fuel Type</b>	Diesel	<b>Type of Body</b>	Utility Vehicle
<b>Colour</b>	White

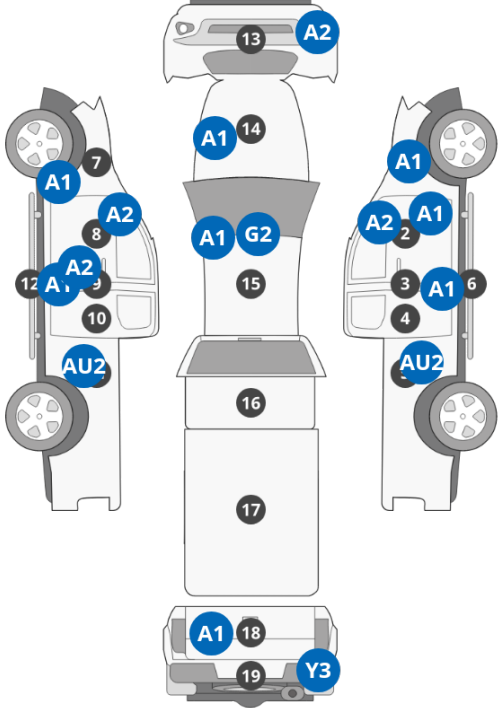
<p><b>A</b> : Scratch <b>AU</b> : Scratch &amp; Dent <b>B</b> : Modified <b>C</b> : Corrosion <b>G</b> : Stone chip <b>P</b> : Faded <b>S</b> : Rust <b>SC</b> : Rust &amp; Corrosion <b>U</b> : Dent <b>X</b> : Defective <b>Y</b> : Crack, Gap</p>
<p><b>Remarks</b> Defects not found</p>	<p><b>Remarks</b> (R) Front Fender, Molding - Scratch - Minimal / (R) Mirror - Scratch - Small / (R) Front Door, Molding - Scratch - Minimal / (R) Center Panel - Scratch - Minimal / (R) Side Gate - Scratch &amp; Dent - Small / Rear Gate - Scratch - Minimal / Rear Bumper, Lamps, Panels - Crack, Gap - Medium / (L) Side Gate - Scratch &amp; Dent - Small / (L) Center Panel - Scratch - Minimal / (L) Mirror - Scratch - Small / (L) Front Door, Molding - Scratch - Small / (L) Front Fender, Molding - Scratch - Minimal / Bonnet, Headlight - Scratch - Minimal / Front Bumper, Grille, Lamps - Scratch - Small / Front Windshield - Scratch, Stone chip - Small / Roof - Scratch - Minimal</p>

<p><b>Inspector Notes</b></p>
<p>with Warranty Booklet, Jack and Tools, with Sparetire and LTO Plate, Scratches and cracked Tail Light, park light issue</p>
