General Information

Make	Toyota	Model	Rush
YOM	2023	Odo Meter Reading	109,213
Registration No.	NIK2485	Chassis No.	MHKE8FF3PPK054795
CC	1.5	Transmission	A/T
Fuel Type	Gas	Type of Body	SUV
Colour	Red

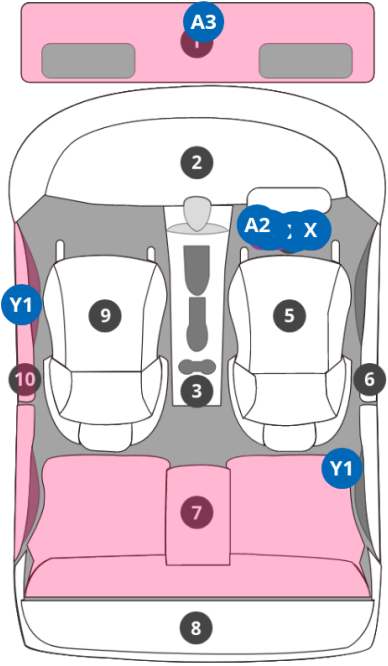
Interior Evaluation : B	Exterior Evaluation : D

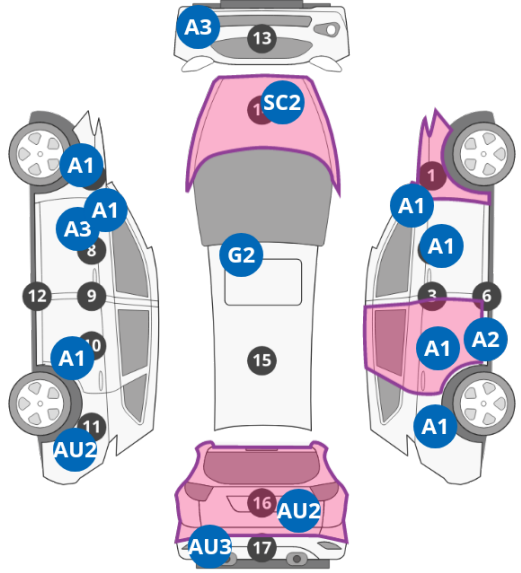
<p>A : Scratch AU : Scratch & Dent B : Modified C : Corrosion G : Stone chip P : Faded S : Rust SC : Rust & Corrosion U : Dent X : Defective Y : Crack, Gap</p>
<p>Remarks Ceiling - Cut, Crack - Medium / (R) Front Floor Mat - Missing - Yes / (L) Front Floor Mat - Missing - Yes / Mat Other - Missing - Yes / (L) Front Trim - Grime - Minimal / Rear Seat - Grime - Minimal / Carpet - Worn, Scratch, Cut, Crack - Small</p>	<p>Remarks (R) Front Door - Repair Traces - Yes / (R) Front Fender - Repair Traces - Yes / Bonnet - Repair Traces - Yes / (L) Front Fender - Repair Traces - Yes / (L) Front Door - Repair Traces - Yes / (L) Rear Door - Repair Traces - Yes / (L) Rear Fender - Repair Traces - Yes / Trunk Hood, Rear Gate - Repair Traces - Yes / (R) Rear Fender - Repair Traces - Yes / (R) Rear Door - Repair Traces - Yes / Roof - Repair Traces - Yes / (R) Front Fender, Molding - Repair mark - Yes / (R) Mirror - Scratch - Minimal / (R) Front Door, Molding - Scratch - Minimal / (R) Rear Door, Molding - Repair mark - Yes / (R) Step, In-panel, Side Spoiler - Scratch - Small / (R) Rear Door, Molding - Scratch - Minimal / (R) Rear Fender, Molding - Scratch - Minimal / Rear Bumper, Lamps, Panels - Scratch & Dent - Medium / Trunk Hood, Rear Gate - Scratch & Dent - Small / (L) Rear Fender, Molding - Scratch & Dent - Small / Front Windshield - Scratch, Stone chip - Small / (L) Rear Door, Molding - Scratch - Minimal / (L) Front Door, Molding - Scratch - Medium / (L) Front Fender, Molding - Scratch - Minimal / Bonnet, Headlight - Repair mark - Yes / Bonnet, Headlight - Rust, Corrosion - Small / Front Bumper, Grille, Lamps - Scratch - Medium / (L) Mirror - Scratch - Minimal / Trunk Hood, Rear Gate - Repair mark - Yes</p>

<p>Inspector Notes</p>
<p>With Lto plate, with spare and jack, 2keys, no warranty booklet, no tools, scratches on headlights, Crack taillight</p>
