General Information

Make	Suzuki	Model	Carry
YOM	2022	Odo Meter Reading	34,097
Registration No.	NIB7474	Chassis No.	MHYHDC01MI916235
CC	1.5	Transmission	M/T
Fuel Type	Diesel	Type of Body	Utility Vehicle
Colour	White

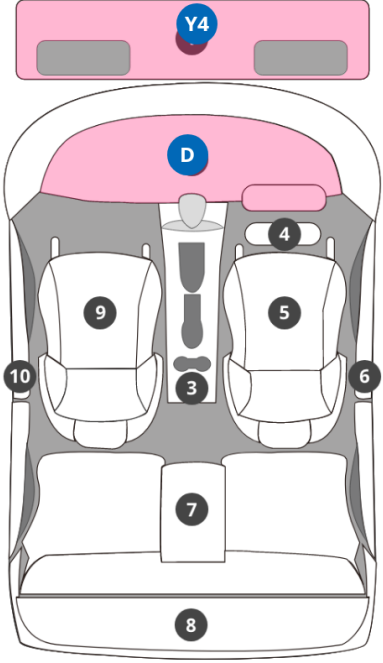
Interior Evaluation : C	Exterior Evaluation : D

<p>a : Cut, Fray d : Loose, Deformed k : Animal Hair s : Smell t : Cigarette Burns x : Defective y : Stain</p>

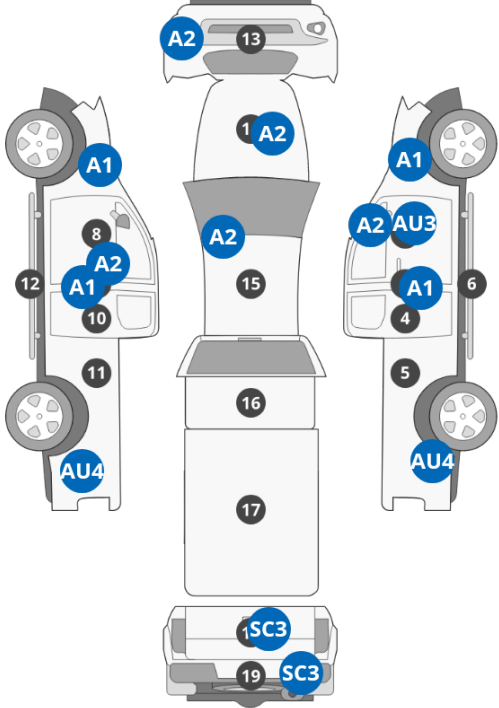
<p>A : Scratch AU : Scratch & Dent B : Modified C : Corrosion G : Stone chip P : Faded S : Rust SC : Rust & Corrosion U : Dent X : Defective Y : Crack, Gap</p>
<p>Remarks Ceiling - Grime - Large / Overall Interior - Worn as per age - Yes / Dashboard - Traces of Adhesive Tape - Yes</p>	<p>Remarks (R) Front Fender, Molding - Scratch - Minimal / (R) Mirror - Scratch - Small / (R) Front Door, Molding - Scratch & Dent - Medium / (R) Center Panel - Scratch - Minimal / (R) Side Gate - Scratch & Dent - Large / (L) Side Gate - Scratch & Dent - Large / Rear Bumper, Lamps, Panels - Rust, Corrosion - Medium / Rear Gate - Rust, Corrosion - Medium / (L) Center Panel - Scratch - Minimal / Front Panel - Scratch - Small / Roof - Scratch - Small / (L) Front Fender, Molding - Scratch - Minimal / Front Bumper, Grille, Lamps - Scratch - Small / (L) Front Door, Molding - Scratch - Small</p>
