## General Information

<b>Make</b>	Mitsubishi	<b>Model</b>	Xpander
<b>YOM</b>	2021	<b>Odo Meter Reading</b>	127,416
<b>Registration No.</b>	GAT6057	<b>Chassis No.</b>	MK2LNNC1WMN000739
<b>CC</b>	1.5	<b>Transmission</b>	M/T
<b>Fuel Type</b>	Gas	<b>Type of Body</b>	Wagon
<b>Colour</b>	Gray

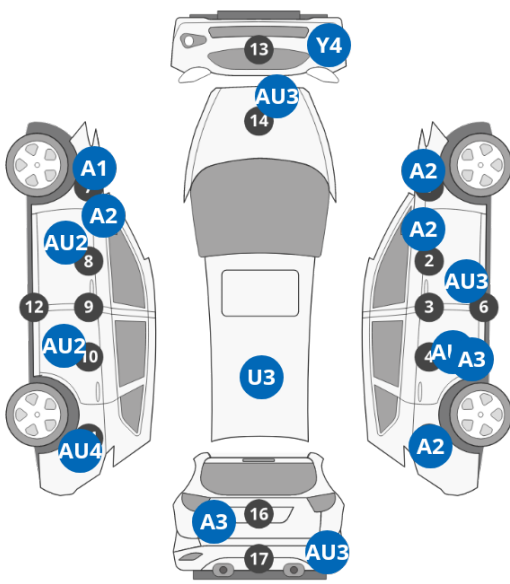
<p><b>A</b> : Scratch <b>AU</b> : Scratch &amp; Dent <b>B</b> : Modified <b>C</b> : Corrosion <b>G</b> : Stone chip <b>P</b> : Faded <b>S</b> : Rust <b>SC</b> : Rust &amp; Corrosion <b>U</b> : Dent <b>X</b> : Defective <b>Y</b> : Crack, Gap</p>
<p><b>Remarks</b> (R) Front Seat - Grime - Small / Ceiling - Grime - Large / Rear Seat - Grime - Small / (R) Front Trim - Grime - Small / (R) Rear Trim - Crinkle - Small / Trunk Room - Worn, Scratch, Cut, Crack - Small / (L) Front Trim - Grime - Minimal / (L) Rear Trim - Grime - Minimal / Steering Wheel - Worn, Peel, Crack - Medium / (L) Front Seat - Grime - Minimal</p>	<p><b>Remarks</b> (L) Rear Door, Molding - Scratch &amp; Dent - Small / (L) Front Door, Molding - Scratch &amp; Dent - Small / (L) Mirror - Scratch - Small / (L) Front Fender, Molding - Scratch - Minimal / (L) Rear Fender, Molding - Scratch &amp; Dent - Large / Trunk Hood, Rear Gate - Scratch - Medium / Rear Bumper, Lamps, Panels - Scratch &amp; Dent - Medium / (R) Rear Fender, Molding - Scratch - Small / (R) Rear Door, Molding - Scratch &amp; Dent - Large / (R) Step, In-panel, Side Spoiler - Scratch - Medium / (R) Front Door, Molding - Scratch &amp; Dent - Medium / (R) Mirror - Scratch - Small / (R) Front Fender, Molding - Scratch - Small / Front Bumper, Grille, Lamps - Crack, Gap - Large / Bonnet, Headlight - Scratch &amp; Dent - Medium / Roof - Dent - Medium</p>
