## General Information

<b>Make</b>	Toyota	<b>Model</b>	Vios
<b>YOM</b>	2021	<b>Odo Meter Reading</b>	64,127
<b>Registration No.</b>	DAP8695	<b>Chassis No.</b>	PA1B18F32M4157229
<b>CC</b>	1.3	<b>Transmission</b>	CVT
<b>Fuel Type</b>	Gas	<b>Type of Body</b>	Sedan
<b>Colour</b>	Silver

## Body / Panel Condition

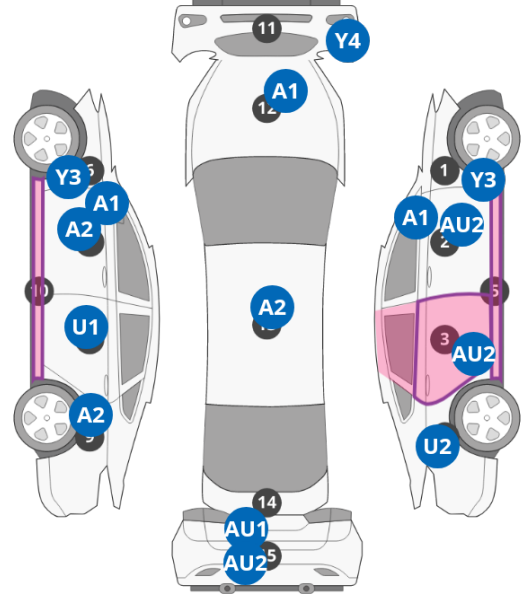
<p><b>A</b> : Scratch <b>AU</b> : Scratch &amp; Dent <b>B</b> : Modified <b>C</b> : Corrosion <b>G</b> : Stone chip <b>P</b> : Faded <b>S</b> : Rust <b>SC</b> : Rust &amp; Corrosion <b>U</b> : Dent <b>X</b> : Defective <b>Y</b> : Crack, Gap</p>
<p><b>Remarks</b> (R) Front Floor Mat - Missing - Yes / (L) Front Floor Mat - Missing - Yes / Mat Other - Missing - Yes / (R) Front Seat - Grime - Medium / (L) Front Trim - Grime - Small</p>	<p><b>Remarks</b> (R) Front Door - Repair Traces - Yes / (R) Front Fender - Repair Traces - Yes / Bonnet - Repair Traces - Yes / (L) Front Fender - Repair Traces - Yes / (L) Front Door - Repair Traces - Yes / (L) Step - Repair Traces - Yes / (L) Rear Door - Repair Traces - Yes / (L) Rear Fender - Repair Traces - Yes / Trunk Hood, Rear Gate - Repair Traces - Yes / (R) Rear Fender - Repair Traces - Yes / (R) Rear Door - Repair Traces - Yes / Roof - Repair Traces - Yes / Overall Exterior - Full Re-Paint in same color - Yes / (R) Front Fender, Molding - Crack, Gap - Medium / (R) Mirror - Scratch - Minimal / (R) Front Door, Molding - Scratch &amp; Dent - Small / (R) Rear Door, Molding - Repair mark - Difference in Color / (R) Rear Door, Molding - Scratch &amp; Dent - Small / (R) Step, In-panel, Side Spoiler - Repair mark - Difference in Color / (R) Rear Fender, Molding - Dent - Small / Trunk Hood, Rear Gate - Scratch &amp; Dent - Minimal / Rear Bumper, Lamps, Panels - Scratch &amp; Dent - Small / (L) Rear Fender, Molding - Scratch - Small / (L) Step, In-panel, Side Spoiler - Repair mark - Yes / (L) Rear Door, Molding - Dent - Minimal / (L) Mirror - Scratch - Minimal / (L) Front Door, Molding - Scratch - Small / (L) Front Fender, Molding - Crack, Gap - Medium / Front Bumper, Grille, Lamps - Crack, Gap - Large / Bonnet, Headlight - Scratch - Minimal / Roof - Scratch - Small</p>
