## General Information

<b>Make</b>	Toyota	<b>Model</b>	Vios
<b>YOM</b>	2024	<b>Odo Meter Reading</b>	32,433
<b>Registration No.</b>	CCD4463	<b>Chassis No.</b>	PA1B18F33R4259923
<b>CC</b>	1.3	<b>Transmission</b>	CVT
<b>Fuel Type</b>	Gas	<b>Type of Body</b>	Sedan
<b>Colour</b>	Black

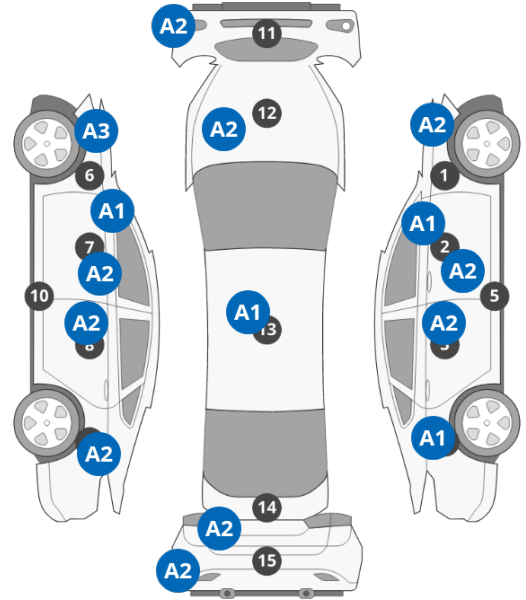
<p><b>A</b> : Scratch <b>AU</b> : Scratch &amp; Dent <b>B</b> : Modified <b>C</b> : Corrosion <b>G</b> : Stone chip <b>P</b> : Faded <b>S</b> : Rust <b>SC</b> : Rust &amp; Corrosion <b>U</b> : Dent <b>X</b> : Defective <b>Y</b> : Crack, Gap</p>
<p><b>Remarks</b> (L) Front Seat - Worn - Yes / (R) Front Seat - Grime - Small / (L) Front Floor Mat - Cut, Crack - Medium / (L) Front Floor Mat - Worked - Large / (R) Front Trim - Grime - Small / (L) Front Trim - Grime - Small / Rear Seat - Grime - Minimal / Ceiling - Grime - Small</p>	<p><b>Remarks</b> (R) Mirror - Scratch - Minimal / (R) Front Fender, Molding - Scratch - Small / (R) Front Door, Molding - Scratch - Small / (R) Rear Door, Molding - Scratch - Small / (R) Rear Fender, Molding - Scratch - Minimal / Rear Bumper, Lamps, Panels - Scratch - Small / Trunk Hood, Rear Gate - Scratch - Small / (L) Rear Fender, Molding - Scratch - Small / (L) Front Door, Molding - Scratch - Small / (L) Rear Door, Molding - Scratch - Small / (L) Front Fender, Molding - Scratch - Medium / (L) Mirror - Scratch - Minimal / Front Bumper, Grille, Lamps - Scratch - Small / Bonnet, Headlight - Scratch - Small / Roof - Scratch - Minimal</p>
