General Information

Date & Time: 19, Jan, 2026 16:27

Make	Toyota	Model	Avanza
YOM	2025	Odo Meter Reading	9,122
Registration No.	BAG6648	Chassis No.	MHFAA1BY6R0032648
CC	1.3	Transmission	CVT
Fuel Type	Gas	Type of Body	Wagon
Colour	Green

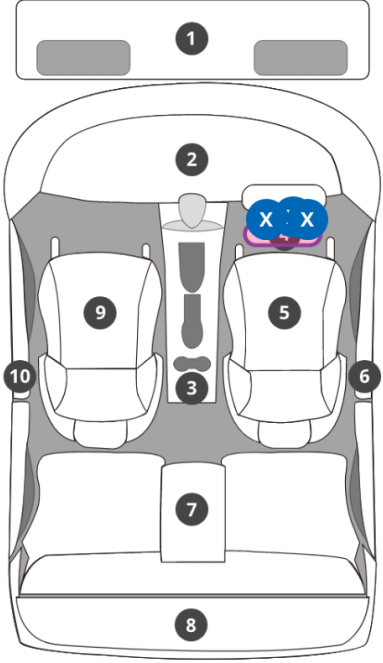
Interior Evaluation : B	Exterior Evaluation : B

<p>a : Cut, Fray d : Loose, Deformed k : Animal Hair s : Smell t : Cigarette Burns x : Defective y : Stain</p>

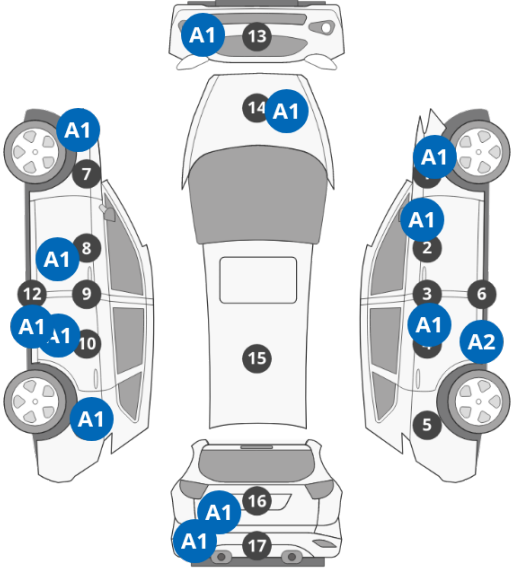
<p>A : Scratch AU : Scratch & Dent B : Modified C : Corrosion G : Stone chip P : Faded S : Rust SC : Rust & Corrosion U : Dent X : Defective Y : Crack, Gap</p>
<p>Remarks (R) Front Floor Mat - Missing - Yes / (L) Front Floor Mat - Missing - Yes / Mat Other - Missing - Yes</p>	<p>Remarks (R) Front Fender - Repair Traces - Yes / Bonnet - Repair Traces - Yes / (L) Front Fender - Repair Traces - Yes / (L) Rear Fender - Repair Traces - Yes / Trunk Hood, Rear Gate - Repair Traces - Yes / (R) Front Fender, Molding - Scratch - Minimal / (R) Front Door, Molding - Scratch - Minimal / (R) Step, In-panel, Side Spoiler - Scratch - Small / (R) Rear Door, Molding - Scratch - Minimal / Trunk Hood, Rear Gate - Scratch - Minimal / Rear Bumper, Lamps, Panels - Scratch - Minimal / (L) Rear Fender, Molding - Scratch - Minimal / (L) Rear Door, Molding - Scratch - Minimal / (L) Step, In-panel, Side Spoiler - Scratch - Minimal / (L) Front Door, Molding - Scratch - Minimal / (L) Front Fender, Molding - Scratch - Minimal / Front Bumper, Grille, Lamps - Scratch - Minimal / Bonnet, Headlight - Scratch - Minimal</p>
