General Information

| Make | Suzuki | Model | S-Presso |
| Registration No. | DCA2655 | Chassis No. | MA3FLS1S7TA538369 |

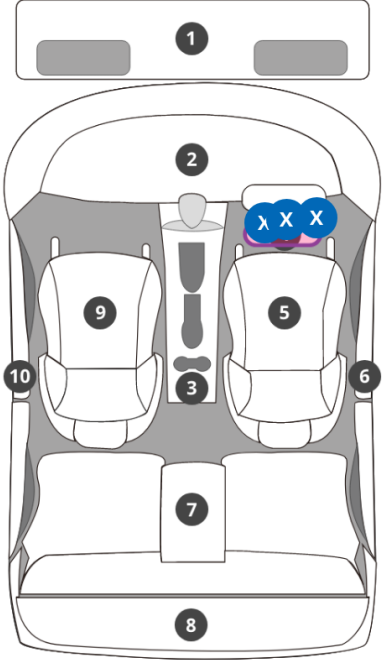
| Interior Evaluation : B | Exterior Evaluation : A |
| <p>Remarks (R) Front Floor Mat - Missing - Yes / (L) Front Floor Mat - Missing - Yes / Mat Other - Missing - Yes</p> | <p>Remarks (R) Front Fender, Molding - Scratch - Minimal / (R) Front Door, Molding - Scratch - Minimal / (R) Rear Door, Molding - Scratch - Minimal / (R) Rear Fender, Molding - Scratch - Minimal / Trunk Hood, Rear Gate - Scratch - Minimal / Rear Bumper, Lamps, Panels - Scratch - Minimal / (L) Rear Door, Molding - Scratch - Minimal / (L) Mirror - Scratch - Minimal / (L) Front Fender, Molding - Scratch - Minimal / Bonnet, Headlight - Scratch - Minimal / Front Bumper, Grille, Lamps - Scratch - Minimal</p> |

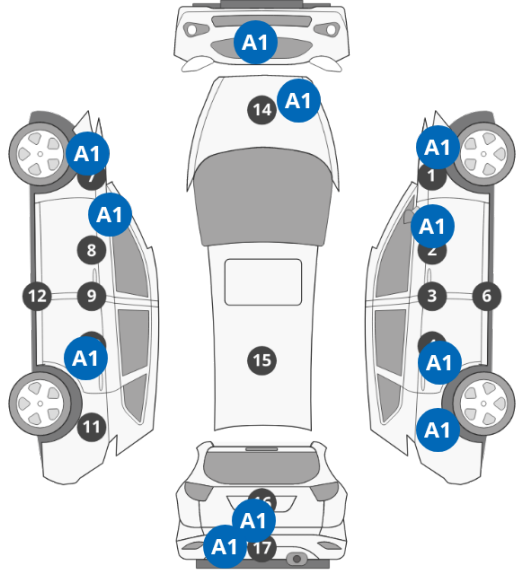
| <p>With Lto plate, 1key, with spare tire, no warranty booklet, no jack and tools, scratches on headlights and taillights,</p> |
