## General Information

<b>Make</b>	Toyota	<b>Model</b>	Wigo
<b>YOM</b>	2022	<b>Odo Meter Reading</b>	45,070
<b>Registration No.</b>	NFL3437	<b>Chassis No.</b>	MHKA4DF5FNJ067923
<b>CC</b>	1.0	<b>Transmission</b>	A/T
<b>Fuel Type</b>	Gas	<b>Type of Body</b>	Hatchback
<b>Colour</b>	Gray

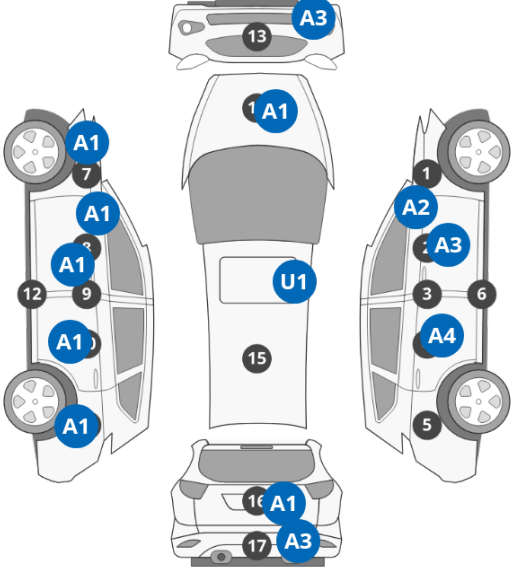
<p><b>A</b> : Scratch <b>AU</b> : Scratch &amp; Dent <b>B</b> : Modified <b>C</b> : Corrosion <b>G</b> : Stone chip <b>P</b> : Faded <b>S</b> : Rust <b>SC</b> : Rust &amp; Corrosion <b>U</b> : Dent <b>X</b> : Defective <b>Y</b> : Crack, Gap</p>
<p><b>Remarks</b> Ceiling - Grime - Small / Console, Switches, Vents - Loose, Deformed - Small</p>	<p><b>Remarks</b> (R) Mirror - Scratch - Small / (R) Front Door, Molding - Scratch - Medium / (R) Rear Door, Molding - Scratch - Large / Roof - Dent - Minimal / Rear Bumper, Lamps, Panels - Scratch - Medium / Trunk Hood, Rear Gate - Scratch - Minimal / (L) Rear Fender, Molding - Scratch - Minimal / (L) Rear Door, Molding - Scratch - Minimal / (L) Front Door, Molding - Scratch - Minimal / (L) Front Fender, Molding - Scratch - Minimal / (L) Mirror - Scratch - Minimal / Front Bumper, Grille, Lamps - Scratch - Medium / Bonnet, Headlight - Scratch - Minimal</p>

<p><b>Inspector Notes</b></p>
<p>With lto plate, with spare tire and jack, 1key, no warranty booklet and tools, scratches on headlights and taillights</p>
