## General Information

<b>Make</b>	Toyota	<b>Model</b>	Vios
<b>YOM</b>	2025	<b>Odo Meter Reading</b>	764
<b>Registration No.</b>	CCQ3199	<b>Chassis No.</b>	PA1B18F34S4294086
<b>CC</b>	1.3	<b>Transmission</b>	CVT
<b>Fuel Type</b>	Gas	<b>Type of Body</b>	Sedan
<b>Colour</b>	Silver

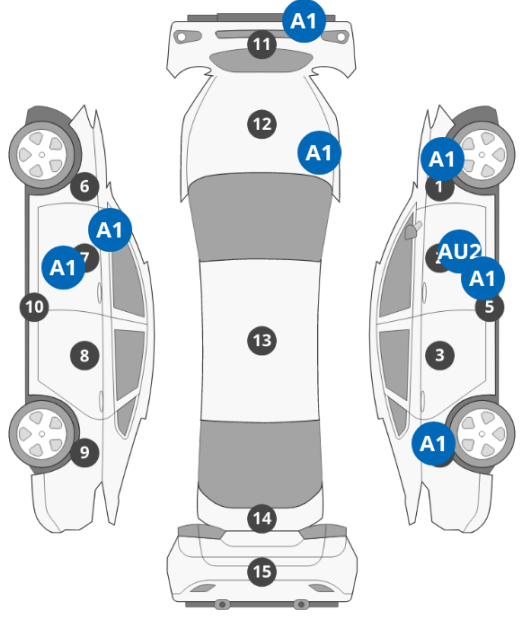
<p><b>a</b> : Cut, Fray <b>d</b> : Loose, Deformed <b>k</b> : Animal Hair <b>s</b> : Smell <b>t</b> : Cigarette Burns <b>x</b> : Defective <b>y</b> : Stain</p>		<p><b>A</b> : Scratch <b>AU</b> : Scratch &amp; Dent <b>B</b> : Modified <b>C</b> : Corrosion <b>G</b> : Stone chip <b>P</b> : Faded <b>S</b> : Rust <b>SC</b> : Rust &amp; Corrosion <b>U</b> : Dent <b>X</b> : Defective <b>Y</b> : Crack, Gap</p>	
<p><b>Remarks</b> Defects not found</p>		<p><b>Remarks</b> (R) Front Fender, Molding - Scratch - Minimal / (R) Front Door, Molding - Scratch &amp; Dent - Small / (R) Step, In-panel, Side Spoiler - Scratch - Minimal / (R) Rear Fender, Molding - Scratch - Minimal / (L) Front Door, Molding - Scratch - Minimal / (L) Mirror - Scratch - Minimal / Front Bumper, Grille, Lamps - Scratch - Minimal / Bonnet, Headlight - Scratch - Minimal</p>

<b>Inspector Notes</b>
With Lto plate, with warranty booklet, with spare tire, with jack and tools, 2keys,scratches on headlight and taillight
