## General Information

<b>Make</b>	Toyota	<b>Model</b>	Vios
<b>YOM</b>	2024	<b>Odo Meter Reading</b>	38,321
<b>Registration No.</b>	DBM6098	<b>Chassis No.</b>	PA1B18F30R4245770
<b>CC</b>	1.3	<b>Transmission</b>	CVT
<b>Fuel Type</b>	Gas	<b>Type of Body</b>	Sedan
<b>Colour</b>	Red

## Body / Panel Condition

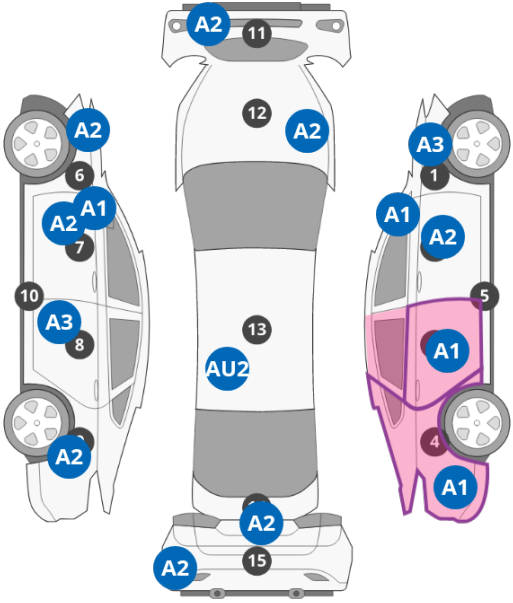
<p><b>A</b> : Scratch <b>AU</b> : Scratch &amp; Dent <b>B</b> : Modified <b>C</b> : Corrosion <b>G</b> : Stone chip <b>P</b> : Faded <b>S</b> : Rust <b>SC</b> : Rust &amp; Corrosion <b>U</b> : Dent <b>X</b> : Defective <b>Y</b> : Crack, Gap</p>
<p><b>Remarks</b> (R) Front Seat - Grime - Small / (R) Front Trim - Grime - Minimal / Rear Seat - Grime - Small / (L) Front Trim - Grime - Medium / (L) Front Seat - Grime - Medium / Ceiling - Grime - Small / Dashboard - Worn, Scratch, Cut, Crack - Minimal</p>	<p><b>Remarks</b> (R) Rear Fender - Repair Traces - Yes / (R) Rear Door - Repair Traces - Yes / (R) Rear Fender, Molding - Repair mark - Yes / (R) Rear Door, Molding - Repair mark - Yes / (R) Mirror - Scratch - Minimal / (R) Front Fender, Molding - Scratch - Medium / (R) Rear Door, Molding - Scratch - Minimal / (R) Rear Fender, Molding - Scratch - Minimal / Trunk Hood, Rear Gate - Scratch - Small / Rear Bumper, Lamps, Panels - Scratch - Small / (L) Rear Fender, Molding - Scratch - Small / (L) Rear Door, Molding - Scratch - Medium / (L) Front Door, Molding - Scratch - Small / (L) Mirror - Scratch - Minimal / (L) Front Fender, Molding - Scratch - Small / Roof - Scratch &amp; Dent - Small / Bonnet, Headlight - Scratch - Small / Front Bumper, Grille, Lamps - Scratch - Small / (R) Front Door, Molding - Scratch - Small</p>
