General Information

Date & Time: 20, Jan, 2026 10:20

Make	Toyota	Model	Wigo
YOM	2021	Odo Meter Reading	35,840
Registration No.	NEP7352	Chassis No.	MHKA4DF5FMJ052179
CC	1.0	Transmission	A/T
Fuel Type	Gas	Type of Body	Hatchback
Colour	Black

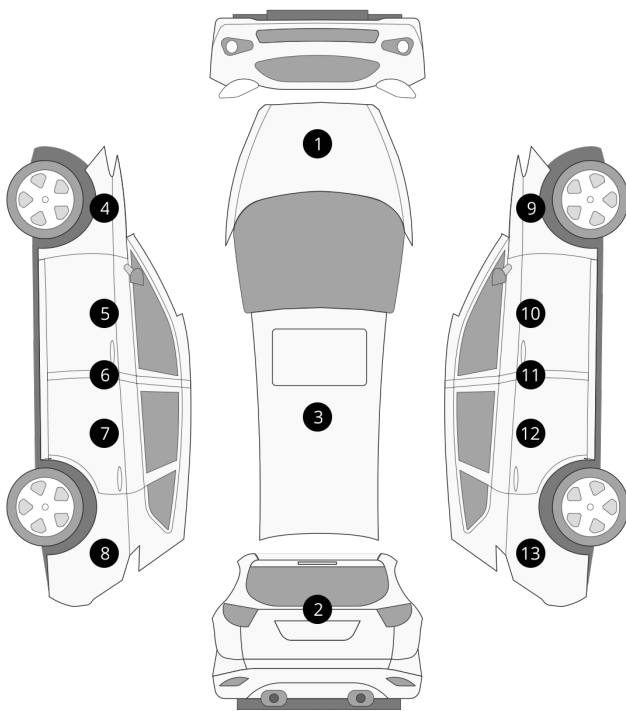
Body / Panel Condition

#	Area	Thickness(um)			
		Average	Value1	Value2	Value3/4
1	Bonnet	145.3	145	150	141
2	Boot Lid	155.0	156	151	158
3	Roof	76.3	66	89	76/75
4	Left Front Fender	181.0	176	183	184
5	Left Front Door	181.6	187	176	182
6	Center Panel Left				
7	Left Rear Door	135.3	141	128	137
8	Left Back Panel	156.6	181	150	139
9	Right Front Fender	210.3	192	207	232
10	Right Front Door	133.3	141	131	128
11	Center Panel Right				
12	Right Rear Door	137.0	149	124	138
13	Right Back Panel	138.0	144	139	131

Interior Evaluation : B	Exterior Evaluation : D
<p>a : Cut, Fray d : Loose, Deformed k : Animal Hair s : Smell t : Cigarette Burns x : Defective y : Stain</p>	<p>A : Scratch AU : Scratch & Dent B : Modified C : Corrosion G : Stone chip P : Faded S : Rust SC : Rust & Corrosion U : Dent X : Defective Y : Crack, Gap</p>
<p>Remarks (L) Front Floor Mat - Worked - Small / Ceiling - Crinkle - Medium / (R) Front Trim - Cut, Crack - Small</p>	<p>Remarks (R) Front Fender - Repair Traces - Yes / (L) Front Fender - Repair Traces - Yes / (L) Front Door - Repair Traces - Yes / Roof - Repair Traces - Yes / (R) Mirror - Scratch - Small / (R) Front Fender, Molding - Scratch - Small / (R) Front Door, Molding - Scratch - Small / (R) Rear Door, Molding - Scratch - Minimal / (R) Rear Fender, Molding - Scratch - Medium / Rear Bumper, Lamps, Panels - Crack, Gap - Medium / Trunk Hood, Rear Gate - Scratch - Minimal / Roof - Dent - Small / (L) Rear Fender, Molding - Dent - Minimal / (L) Mirror - Scratch - Small / (L) Front Door, Molding - Scratch - Medium / (L) Rear Door, Molding - Scratch - Small / (L) Front Fender, Molding - Scratch - Small / Front Bumper, Grille, Lamps - Repair mark - Yes / Front Bumper, Grille, Lamps - Crack, Gap - Medium / Bonnet, Headlight - Scratch - Minimal</p>
