## General Information

<b>Make</b>	Toyota	<b>Model</b>	Hilux
<b>YOM</b>	2023	<b>Odo Meter Reading</b>	85,649
<b>Registration No.</b>	DBG9390	<b>Chassis No.</b>	MR0CB8CDXN0419213
<b>CC</b>	2.4	<b>Transmission</b>	M/T
<b>Fuel Type</b>	Diesel	<b>Type of Body</b>	Pickup
<b>Colour</b>	White

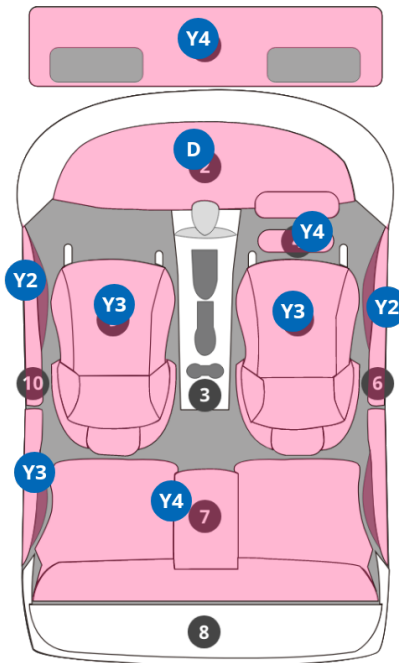
<b>Interior Evaluation :</b> <span style="float: right;"><b>D</b></span>	<b>Exterior Evaluation :</b> <span style="float: right;"><b>E</b></span>

<p><b>A</b> : Scratch <b>AU</b> : Scratch &amp; Dent <b>B</b> : Modified <b>C</b> : Corrosion <b>G</b> : Stone chip <b>P</b> : Faded <b>S</b> : Rust <b>SC</b> : Rust &amp; Corrosion <b>U</b> : Dent <b>X</b> : Defective <b>Y</b> : Crack, Gap</p>
<b>Remarks</b> (R) Front Seat - Grime - Medium / (R) Front Trim - Grime - Small / (L) Front Seat - Grime - Medium / (L) Front Floor Mat - Grime - Large / (L) Front Trim - Grime - Small / (L) Rear Trim - Grime - Medium / Rear Seat - Grime - Large / Ceiling - Grime - Large / Dashboard - Traces of Adhesive Tape - Yes	<b>Remarks</b> (L) Center Panel - Repair Traces - Yes / Rear Gate - Scratch & Dent - Large / (L) Guard Frame - Scratch & Dent - Large / (R) Rear Door, Molding - Scratch & Dent - Large / (R) Guard Frame - Scratch - Large / (R) Front Door, Molding - Scratch - Medium / (R) Front Fender, Molding - Scratch - Medium / (R) Mirror - Scratch - Medium / Bonnet, Headlight - Scratch - Medium / Front Bumper, Grille, Lamps - Scratch - Medium / (L) Front Fender, Molding - Scratch - Small / (L) Mirror - Scratch - Minimal / (L) Front Door, Molding - Scratch - Medium / (L) Step, In-panel, Side Spoiler - Scratch - Medium / (L) Rear Door, Molding - Scratch - Medium / Cab Back Panel - Scratch - Minimal / Roof - Scratch - Medium / Cargo Bed Floor - Scratch - Small / (L) Center Panel - Repair mark - Yes / Front Windshield - Damaged - Large
