## General Information

| Make | Toyota | Model | Raize |
| YOM | 2023 | Odo Meter Reading | 29,194 |
| Registration No. | DBI7250 | Chassis No. | MHKAB1BA9PJ049427 |

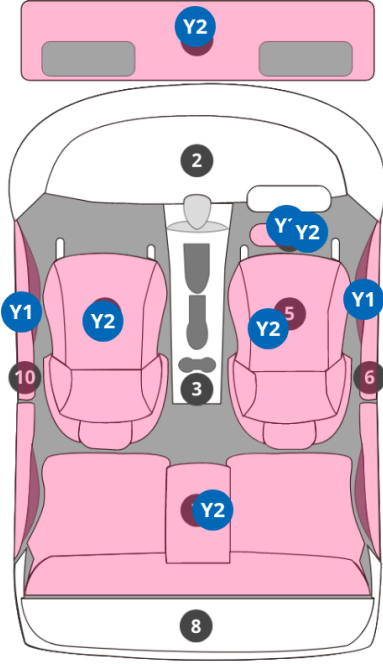
| <p><b>Remarks</b><br/>(L) Front Floor Mat - Grime - Medium / (R) Front Floor Mat - Grime - Small / (L) Front Seat - Grime - Small / (R) Front Seat - Grime - Small / Rear Seat - Grime - Small / Ceiling - Grime - Small / (L) Front Trim - Grime - Minimal / (R) Front Trim - Grime - Minimal</p> | <p><b>Remarks</b><br/>(R) Front Door - Repair Traces - Yes / (L) Front Door - Repair Traces - Yes / Trunk Hood, Rear Gate - Scratch &amp; Dent - Small / Rear Bumper, Lamps, Panels - Scratch - Small / (R) Rear Fender, Molding - Scratch - Minimal / Roof - Scratch &amp; Dent - Minimal / (R) Rear Door, Molding - Scratch &amp; Dent - Minimal / (R) Front Door, Molding - Scratch &amp; Dent - Small / (R) Front Fender, Molding - Scratch - Minimal / Bonnet, Headlight - Scratch &amp; Dent - Minimal / (L) Front Fender, Molding - Scratch - Small / Front Bumper, Grille, Lamps - Scratch - Small / (L) Front Door, Molding - Scratch &amp; Dent - Minimal / (L) Rear Door, Molding - Scratch &amp; Dent - Small / (L) Rear Fender, Molding - Scratch - Small</p> |
