## General Information

Date & Time: 20, Jan, 2026 19:18

<b>Make</b>	Toyota	<b>Model</b>	Hiace
<b>YOM</b>	2024	<b>Odo Meter Reading</b>	48,035
<b>Registration No.</b>	DBN3083	<b>Chassis No.</b>	JTFJT02P5P5035241
<b>CC</b>	3.0	<b>Transmission</b>	M/T
<b>Fuel Type</b>	Diesel	<b>Type of Body</b>	Van
<b>Colour</b>	White

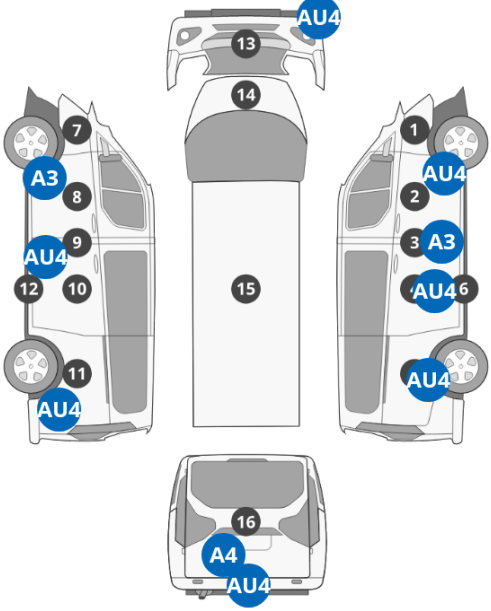
<p><b>A</b> : Scratch <b>AU</b> : Scratch &amp; Dent <b>B</b> : Modified <b>C</b> : Corrosion <b>G</b> : Stone chip <b>P</b> : Faded <b>S</b> : Rust <b>SC</b> : Rust &amp; Corrosion <b>U</b> : Dent <b>X</b> : Defective <b>Y</b> : Crack, Gap</p>
<p><b>Remarks</b> (L) Front Floor Mat - Worked - Large / Overall Interior - Worn as per age - Yes / (L) Rear Trim - Worked - Large / (R) Rear Trim - Worked - Large / Ceiling - Grime - Large</p>	<p><b>Remarks</b> Front Bumper, Grille, Lamps - Scratch &amp; Dent - Large / (R) Front Door, Molding - Scratch &amp; Dent - Large / (R) Center Panel - Scratch - Medium / (R) Rear Door, Molding - Scratch &amp; Dent - Large / (R) Rear Fender, Molding - Scratch &amp; Dent - Large / Rear Bumper, Lamps, Panels - Scratch &amp; Dent - Large / Trunk Hood, Rear Gate - Scratch - Large / (L) Rear Fender, Molding - Scratch &amp; Dent - Large / (L) Rear Door, Molding - Scratch &amp; Dent - Large / (L) Front Door, Molding - Scratch - Medium</p>
