## General Information

Date & Time: 19, Jan, 2026 15:54

<b>Make</b>	Toyota	<b>Model</b>	Vios
<b>YOM</b>	2024	<b>Odo Meter Reading</b>	31,748
<b>Registration No.</b>	DBO7284	<b>Chassis No.</b>	PA1B18F32R4256401
<b>CC</b>	1.3	<b>Transmission</b>	CVT
<b>Fuel Type</b>	Gas	<b>Type of Body</b>	Sedan
<b>Colour</b>	Red Mica Metallic

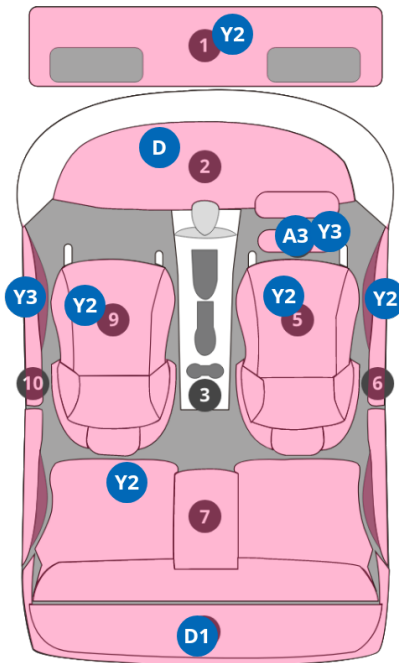
<b>Interior Evaluation :</b> <span style="float: right; color: red; font-weight: bold;">C</span>	<b>Exterior Evaluation :</b> <span style="float: right; color: red; font-weight: bold;">E</span>

<p><b>a</b> : Cut, Fray <b>d</b> : Loose, Deformed <b>k</b> : Animal Hair <b>s</b> : Smell <b>t</b> : Cigarette Burns <b>x</b> : Defective <b>y</b> : Stain</p>

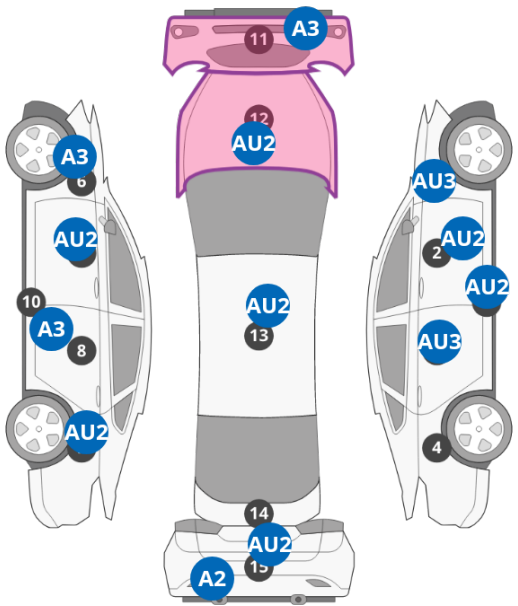
<p><b>A</b> : Scratch <b>AU</b> : Scratch &amp; Dent <b>B</b> : Modified <b>C</b> : Corrosion <b>G</b> : Stone chip <b>P</b> : Faded <b>S</b> : Rust <b>SC</b> : Rust &amp; Corrosion <b>U</b> : Dent <b>X</b> : Defective <b>Y</b> : Crack, Gap</p>
<p><b>Remarks</b> Dashboard - Traces of Adhesive Tape - Yes / (L) Front Trim - Grime - Medium / (R) Front Trim - Grime - Small / (L) Front Floor Mat - Cut, Crack - Medium / (R) Front Floor Mat - Grime - Medium / (L) Front Seat - Grime - Small / (R) Front Seat - Grime - Small / Rear Seat - Grime - Small / Ceiling - Grime - Small / Trunk Room - Worked - Minimal</p>	<p><b>Remarks</b> Bonnet - Repair Traces - Yes / Roof - Scratch &amp; Dent - Small / (R) Rear Door, Molding - Scratch &amp; Dent - Medium / (R) Front Door, Molding - Scratch &amp; Dent - Small / (R) Step, In-panel, Side Spoiler - Scratch &amp; Dent - Small / (R) Front Fender, Molding - Scratch &amp; Dent - Medium / Front Bumper, Grille, Lamps - Scratch - Medium / Front Bumper, Grille, Lamps - Repair mark - Yes / Bonnet, Headlight - Repair mark - Yes / Bonnet, Headlight - Scratch &amp; Dent - Small / (L) Front Fender, Molding - Scratch - Medium / (L) Front Door, Molding - Scratch &amp; Dent - Small / (L) Rear Door, Molding - Scratch - Medium / (L) Rear Fender, Molding - Scratch &amp; Dent - Small / Rear Bumper, Lamps, Panels - Scratch - Small / Trunk Hood, Rear Gate - Scratch &amp; Dent - Small</p>
