General Information

Make	Toyota	Model	Avanza
YOM	2024	Odo Meter Reading	21,175
Registration No.	GBA4825	Chassis No.	MHFAA1BY2P0018458
CC	1.3	Transmission	CVT
Fuel Type	Gas	Type of Body	MPV
Colour	Green

Body / Panel Condition

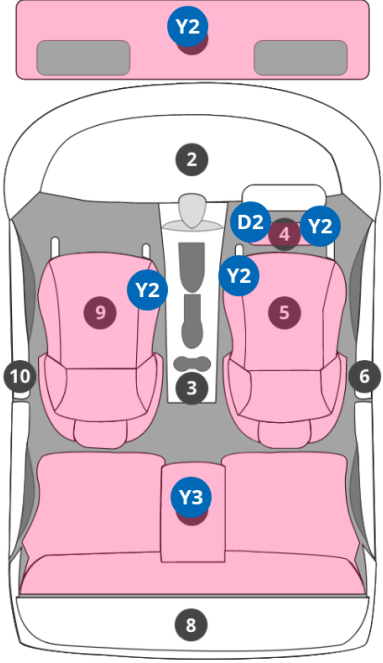
Interior Evaluation : B	Exterior Evaluation : C

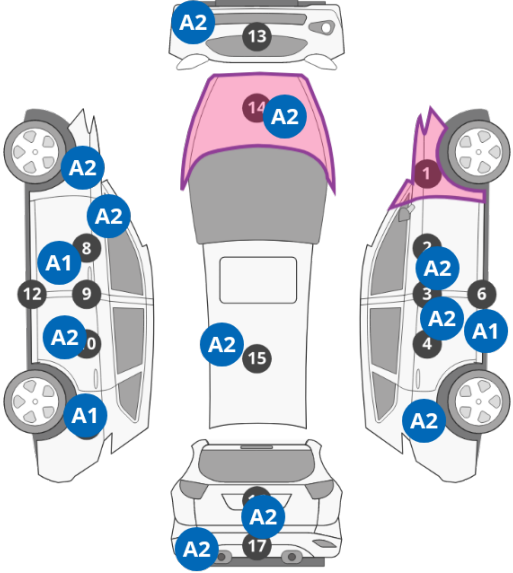
<p>A : Scratch AU : Scratch & Dent B : Modified C : Corrosion G : Stone chip P : Faded S : Rust SC : Rust & Corrosion U : Dent X : Defective Y : Crack, Gap</p>
<p>Remarks (R) Front Floor Mat - Grime - Small / (R) Front Seat - Grime - Small / Ceiling - Grime - Small / Rear Seat - Grime - Medium / (L) Front Seat - Grime - Small / (L) Front Floor Mat - Worked - Small</p>	<p>Remarks (R) Front Fender - Repair Traces - Yes / Bonnet - Repair Traces - Yes / (L) Front Fender - Repair Traces - Yes / Bonnet, Headlight - Repair mark - Yes / (R) Front Fender, Molding - Repair mark - Yes / (L) Front Fender, Molding - Scratch - Small / (L) Mirror - Scratch - Small / (L) Front Door, Molding - Scratch - Minimal / (L) Rear Door, Molding - Scratch - Small / (L) Rear Fender, Molding - Scratch - Minimal / (R) Rear Fender, Molding - Scratch - Small / (R) Rear Door, Molding - Scratch - Small / (R) Front Door, Molding - Scratch - Small / Rear Bumper, Lamps, Panels - Scratch - Small / Trunk Hood, Rear Gate - Scratch - Small / Bonnet, Headlight - Scratch - Small / Front Bumper, Grille, Lamps - Scratch - Small / Roof - Scratch - Small / (R) Step, In-panel, Side Spoiler - Scratch - Minimal</p>
