General Information

Date & Time: 17, Jan, 2026 11:17

Make	Toyota	Model	Fortuner
YOM	2018	Odo Meter Reading	49,559
Registration No.	NDA1521	Chassis No.	MHFHA3FSXJ0566845
CC	2.8	Transmission	A/T
Fuel Type	Diesel	Type of Body	SUV
Colour	White

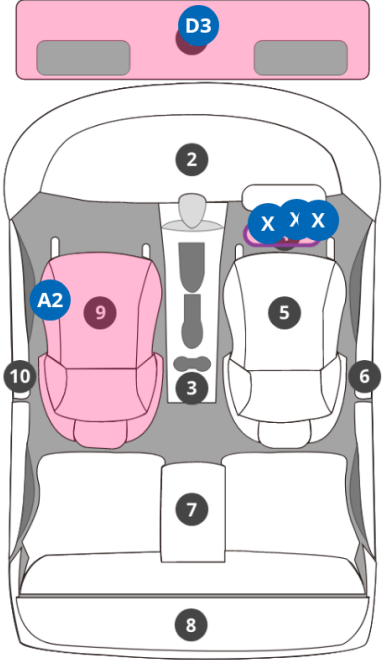
Interior Evaluation : B	Exterior Evaluation : B

<p>a : Cut, Fray d : Loose, Deformed k : Animal Hair s : Smell t : Cigarette Burns x : Defective y : Stain</p>

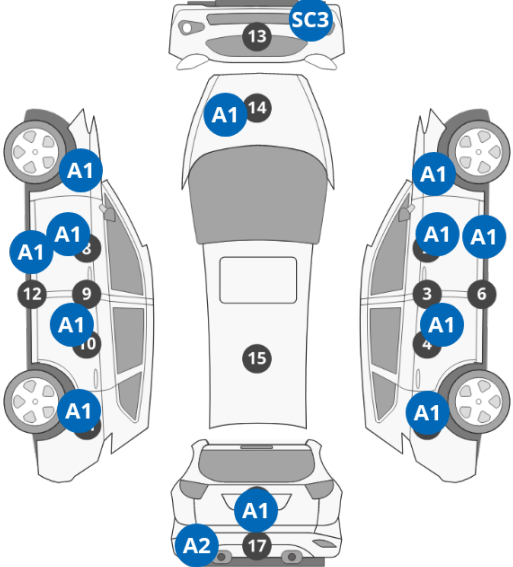
<p>A : Scratch AU : Scratch & Dent B : Modified C : Corrosion G : Stone chip P : Faded S : Rust SC : Rust & Corrosion U : Dent X : Defective Y : Crack, Gap</p>
Remarks (R) Front Floor Mat - Missing - Yes / (L) Front Floor Mat - Missing - Yes / Mat Other - Missing - Yes / Sunvisor, Sunglass Holder - Loose, Deformed - Medium / (L) Front Seat - Fray - Small	Remarks (R) Front Fender - Repair Traces - Yes / (L) Front Fender - Repair Traces - Yes / (L) Front Door - Repair Traces - Yes / (L) Rear Door - Repair Traces - Yes / (L) Rear Fender - Repair Traces - Yes / Trunk Hood, Rear Gate - Repair Traces - Yes / (R) Rear Door - Repair Traces - Yes / Overall Exterior - Full Re-Paint in same color - Yes / (R) Front Fender, Molding - Scratch - Minimal / (R) Front Door, Molding - Scratch - Minimal / (R) Step, In-panel, Side Spoiler - Scratch - Minimal / (R) Rear Door, Molding - Scratch - Minimal / (R) Rear Fender, Molding - Scratch - Minimal / Rear Bumper, Lamps, Panels - Scratch - Small / Trunk Hood, Rear Gate - Scratch - Minimal / (L) Rear Fender, Molding - Scratch - Minimal / (L) Step, In-panel, Side Spoiler - Scratch - Minimal / (L) Rear Door, Molding - Scratch - Minimal / (L) Front Door, Molding - Scratch - Minimal / (L) Front Fender, Molding - Scratch - Minimal / Front Bumper, Grille, Lamps - Rust, Corrosion - Medium / Bonnet, Headlight - Scratch - Minimal
